Depreciation Report

BCS 2634 – Painted Boat Resort Spa and Marina

**RE: Depreciation Report for Strata Plan BCS 2634
File No. 20130318-DR-BCS2634**

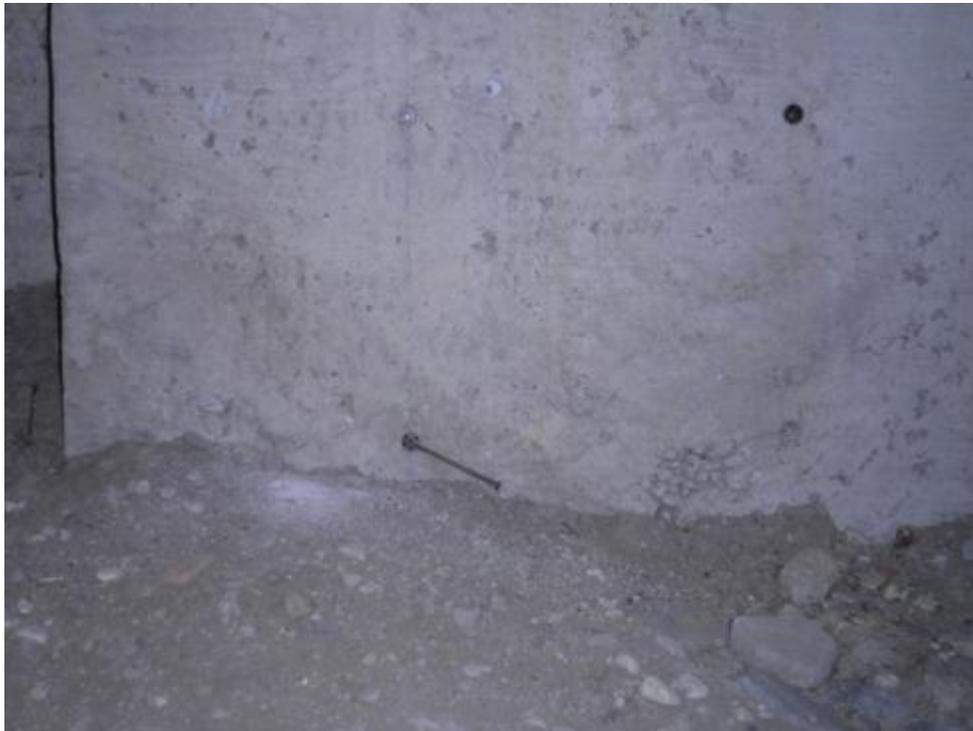
Reserve Component A101002	Foundation walls	
Properties	Concrete foundation walls	
Potential Deterioration	Plantation and soil changes can lead to settling of the structure, causing cracks in the foundation over time. Cracks in concrete walls may lead to water penetration.	
Condition Analysis	<i>Deterioration</i>	Approximately 1 square foot of exposed rebar was found.
	<i>Repair/Replacement History</i>	None available
	<i>Overall Condition</i>	Good
	<i>Date of Installation</i>	2008
Life Cycle Analysis	<i>Chronological Age</i>	5 years
	<i>Estimated Useful Life</i>	50 years
	<i>Effective Age</i>	5 years
	<i>Remaining Useful Life</i>	45 years
Replacement/Repair Estimates	<i>Current Repair/Replacement Cost Estimate</i>	\$ 7,010
	<i>Estimated Year of Repair/Replacement</i>	2058
Preventive Maintenance Recommendations	Cement admixture for permanent repairs of minor cracks. Localized repair of concrete is needed.

Exposed rebar in foundation walls

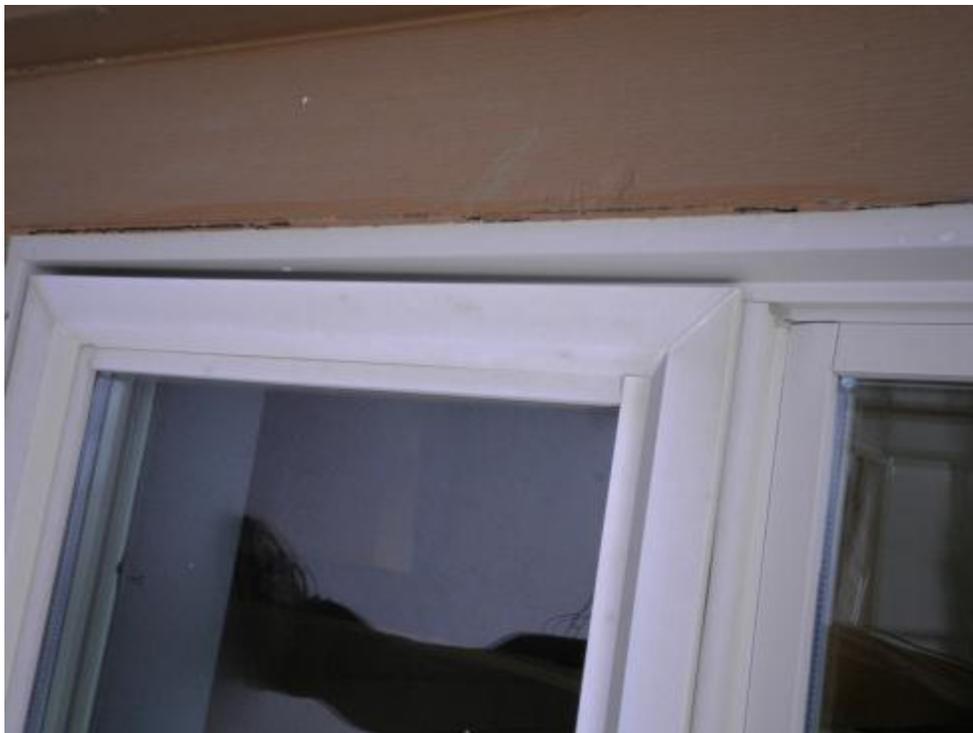
Caulking with signs of deterioration

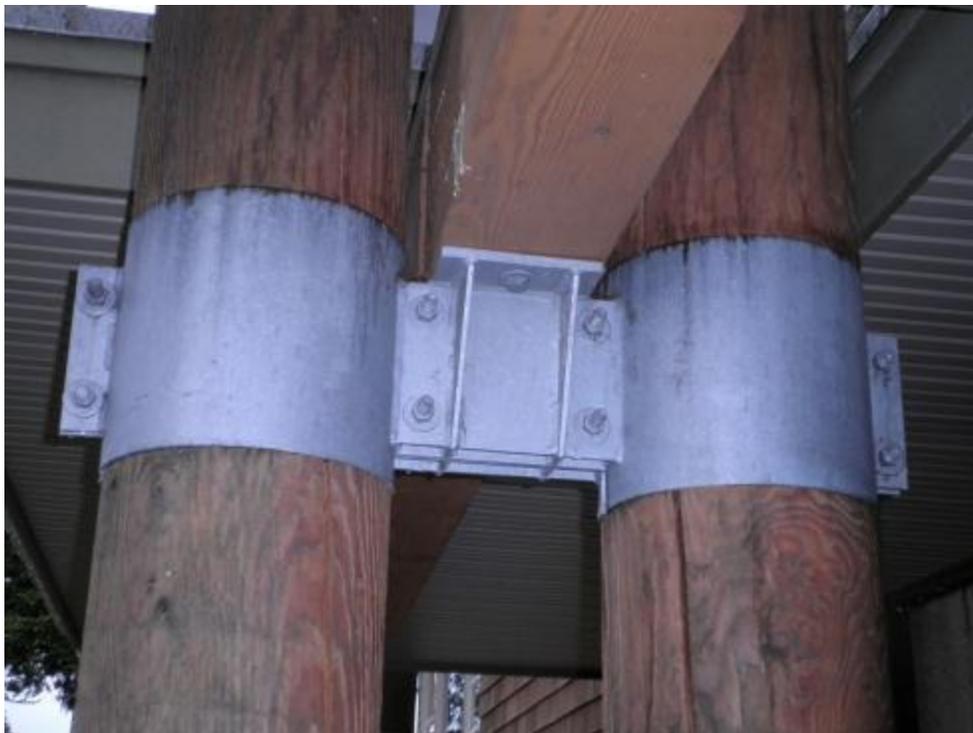
Wooden support columns needing refinishing
