Depreciation Report

BCS 2634 – Painted Boat Resort Spa and Marina

**RE: Depreciation Report for Strata Plan BCS 2634
File No. 20130318-DR-BCS2634**

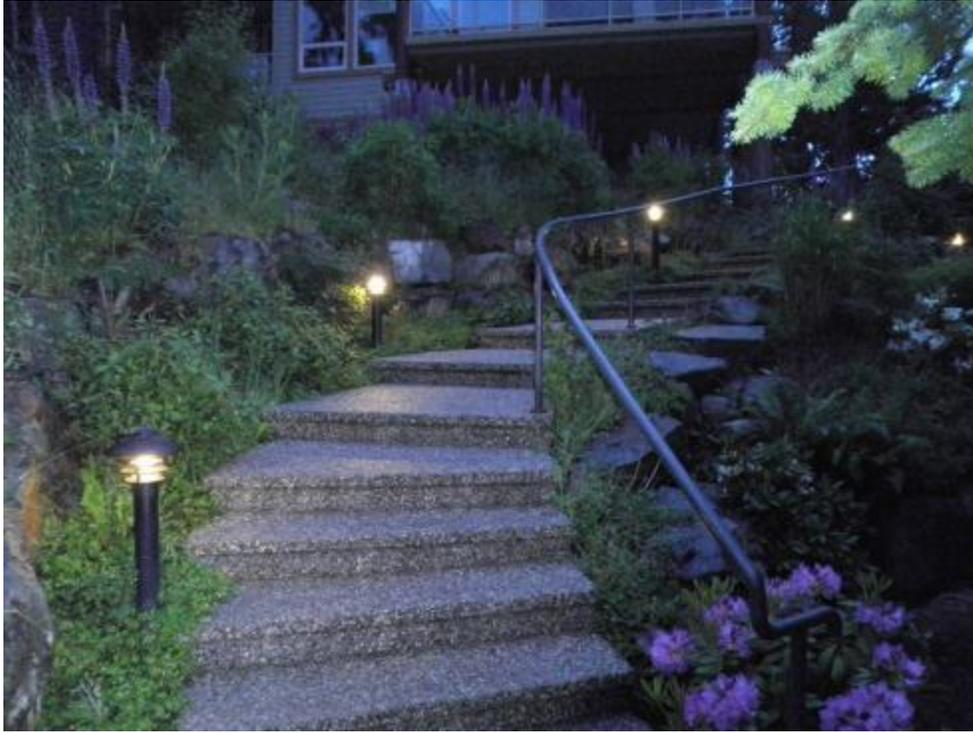
External stairs (concrete aggregate)

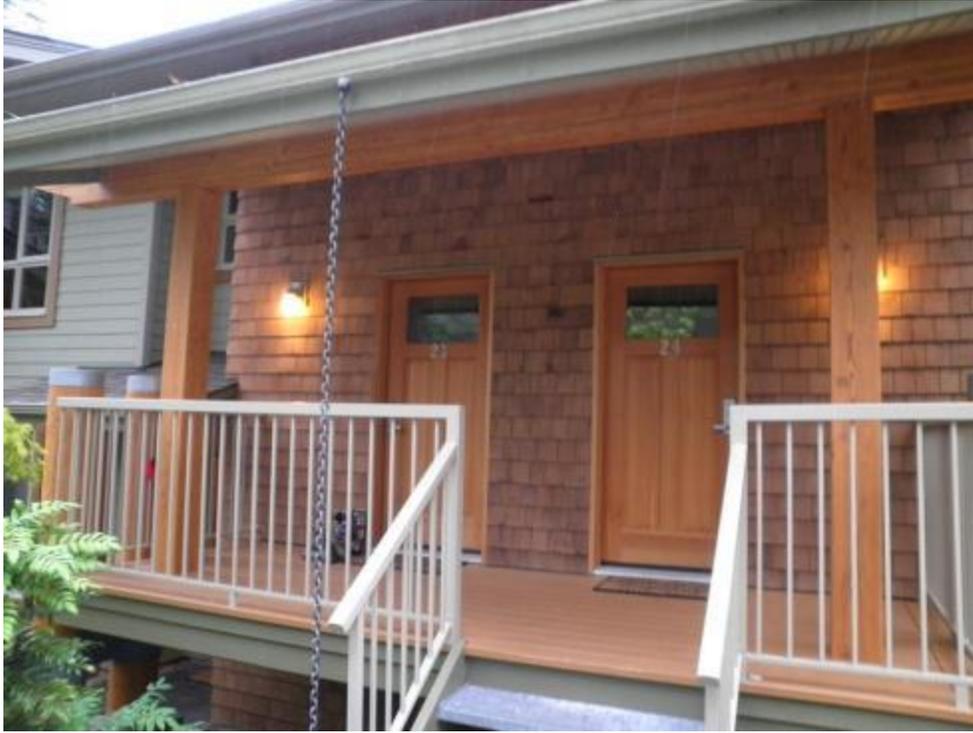
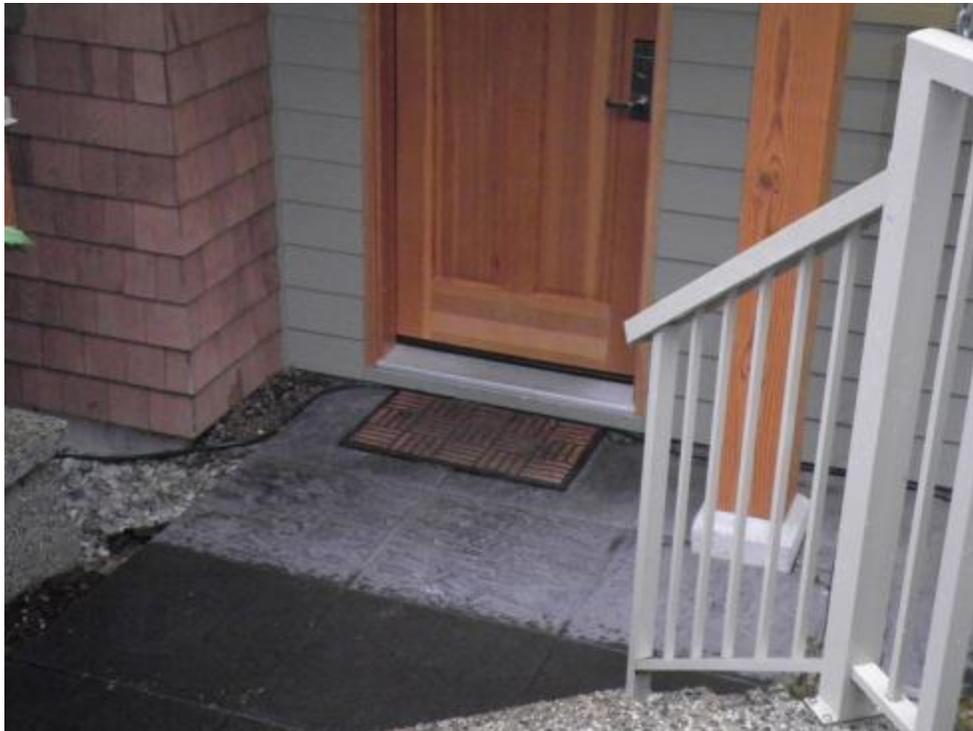
Reserve Component B201008	External stair rails	
Properties	3'-6" high pre-finished aluminum picket railing	
Potential Deterioration	Water may leak through the junction between the guardrail base and the membrane directly onto the underlying wooden frame. This may cause decay in the wood, leading to severe deterioration of the frame itself. Guardrails may also be loose at the junction between the balcony surface and the wall surface after prolonged use.	
Condition Analysis	<i>Deterioration</i>	None observed
	<i>Repair/Replacement History</i>	None available
	<i>Overall Condition</i>	Good
Life Cycle Analysis	<i>Date of Installation</i>	2008
	<i>Chronological Age</i>	5 years
	<i>Estimated Useful Life</i>	50 years
	<i>Effective Age</i>	5 years
	<i>Remaining Useful Life</i>	45 years
Replacement/Repair Estimates	<i>Current Repair/Replacement Cost Estimate</i>	\$ 19,530
	<i>Estimated Year of Repair/Replacement</i>	2058

External stair railing

Preventive Maintenance	Inspect every two years.	
Recommendations	None

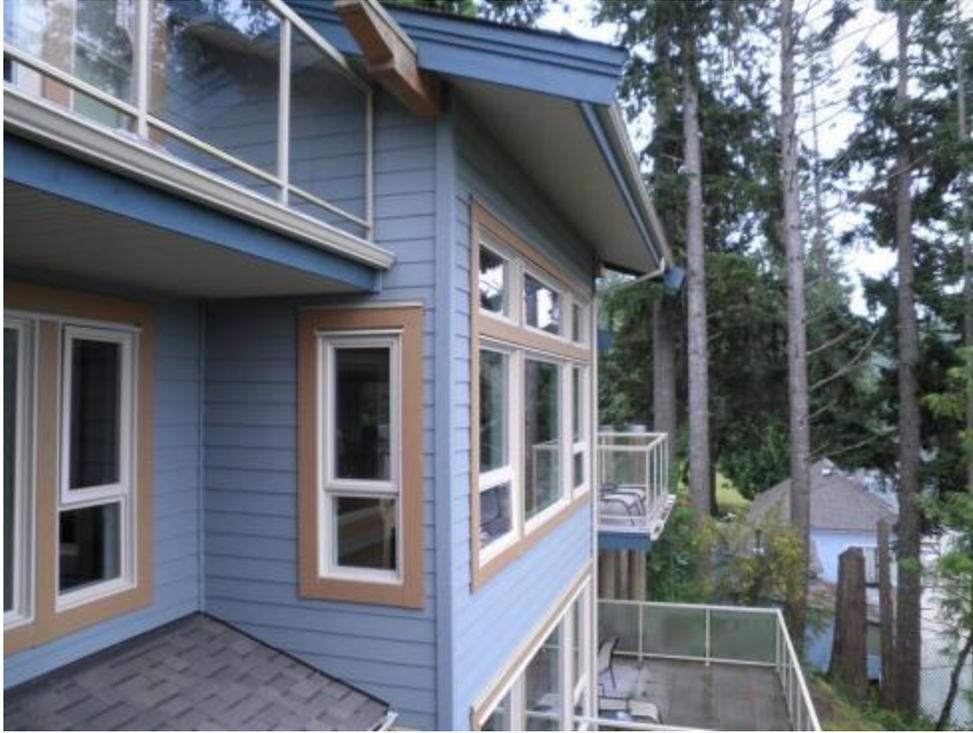
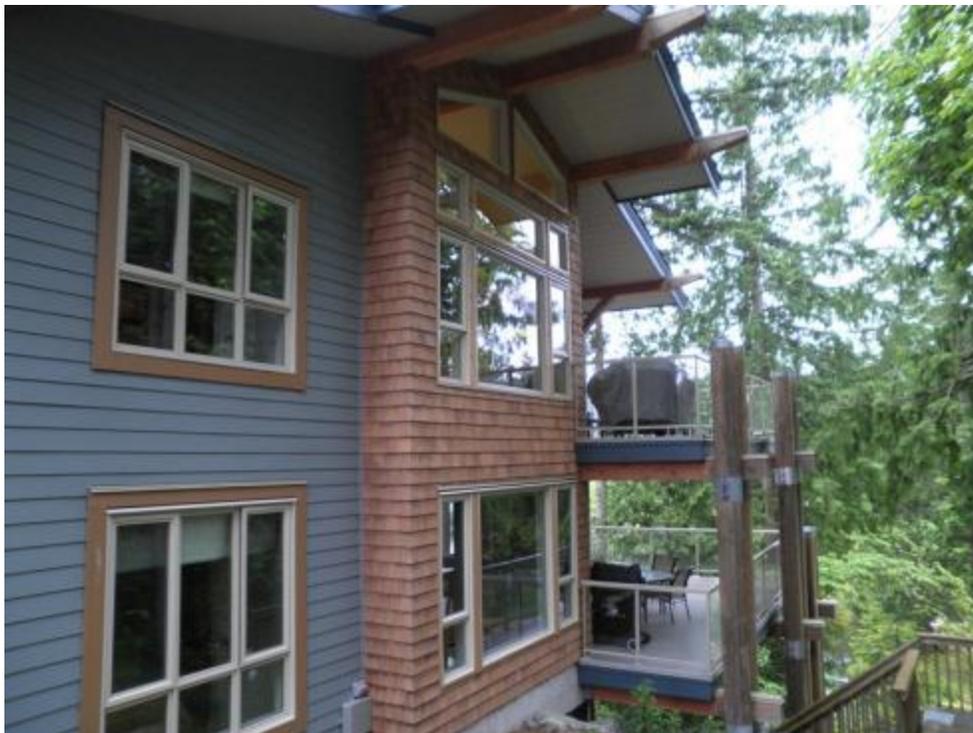
Reserve Component B20200101	Exterior windows	
Properties	Vinyl framed double glazed windows	
Potential Deterioration	Building settlement may lead to the distortion of window frames, which may cause difficulties in opening and closing the windows.	
Condition Analysis	<i>Deterioration</i>	None observed
	<i>Repair/Replacement History</i>	None available
	<i>Overall Condition</i>	Good
Life Cycle Analysis	<i>Date of Installation</i>	2008
	<i>Chronological Age</i>	5 years
	<i>Estimated Useful Life</i>	30 years
	<i>Effective Age</i>	5 years
	<i>Remaining Useful Life</i>	25 years
Replacement/Repair Estimates	<i>Current Repair/Replacement Cost Estimate</i>	\$ 268,296 (cost distributed over 5 years)
	<i>Estimated Year of Repair/Replacement</i>	2038-2042
Preventive Maintenance	Regular washing.	
Recommendations	None

Vinyl-framed double-glazed windows

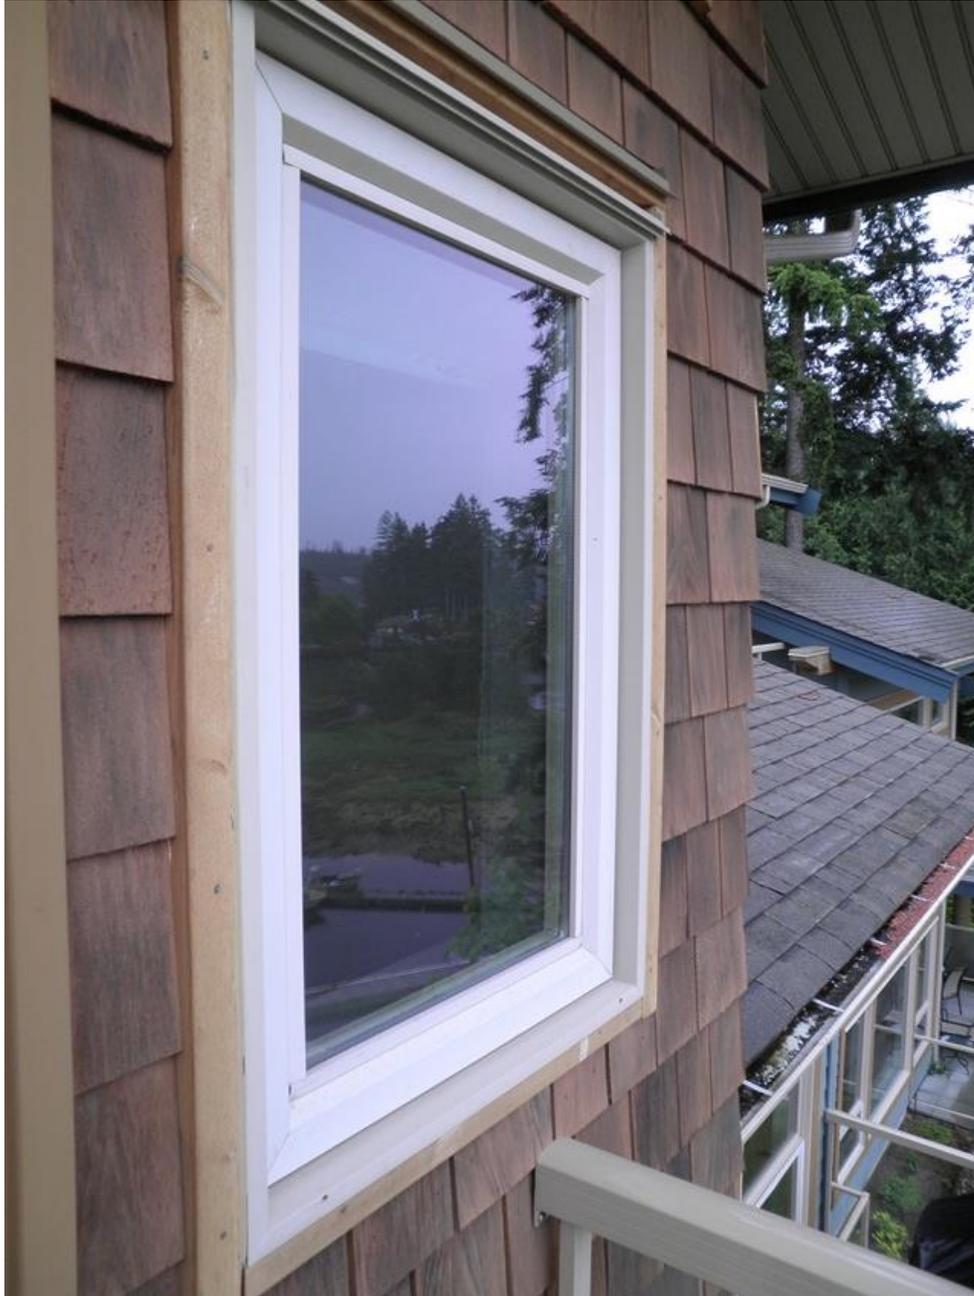
Reserve Component B20200102	Exterior windows (glazing)	
Properties	Vinyl framed double glazed units.	
Potential Deterioration	The seals of the exterior windows may deteriorate over time, decreasing energy efficiency or causing potential failure of seals, leading to fogging of windows. Constant exposure to water can also cause oxidation to metallic parts around windows and discolouration or cause staining. Dirt in window sills may also make closing difficult.	
Condition Analysis	<i>Deterioration</i>	None observed
	<i>Repair/Replacement History</i>	None available
	<i>Overall Condition</i>	Good
Life Cycle Analysis	<i>Date of Installation</i>	2008
	<i>Chronological Age</i>	5 years
	<i>Estimated Useful Life</i>	15 years
	<i>Effective Age</i>	5 years
	<i>Remaining Useful Life</i>	10 years
Replacement/Repair Estimates	<i>Current Repair/Replacement Cost Estimate</i>	\$ 38,328
	<i>Estimated Year of Repair/Replacement</i>	2023

Vinyl-framed double-glazed window

Preventive Maintenance	Regular washing.	
Recommendations	None

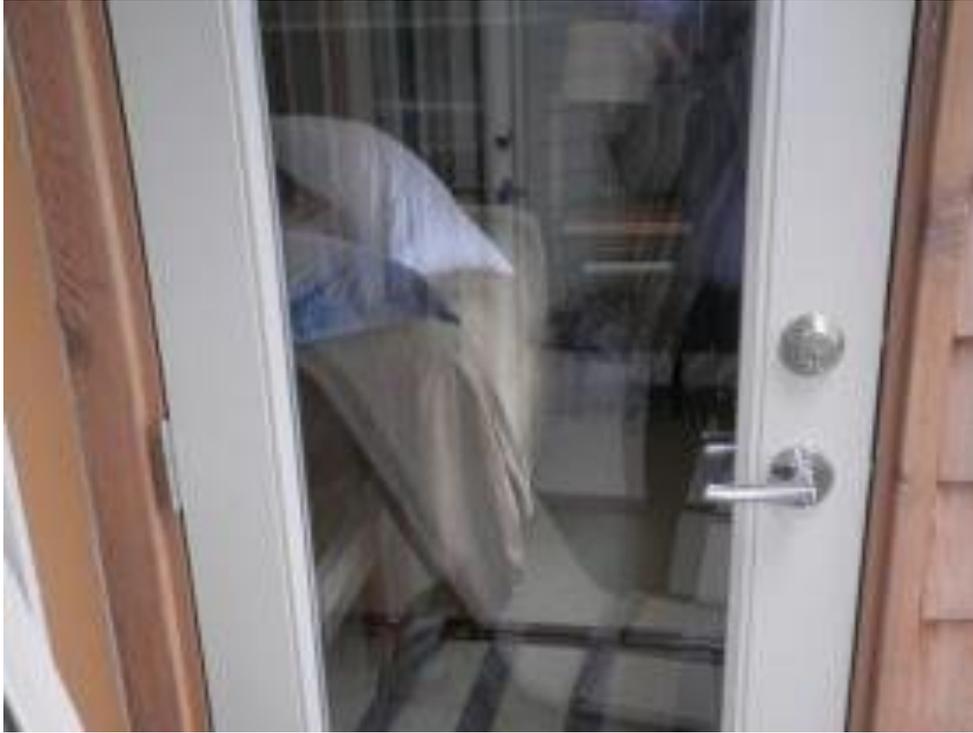
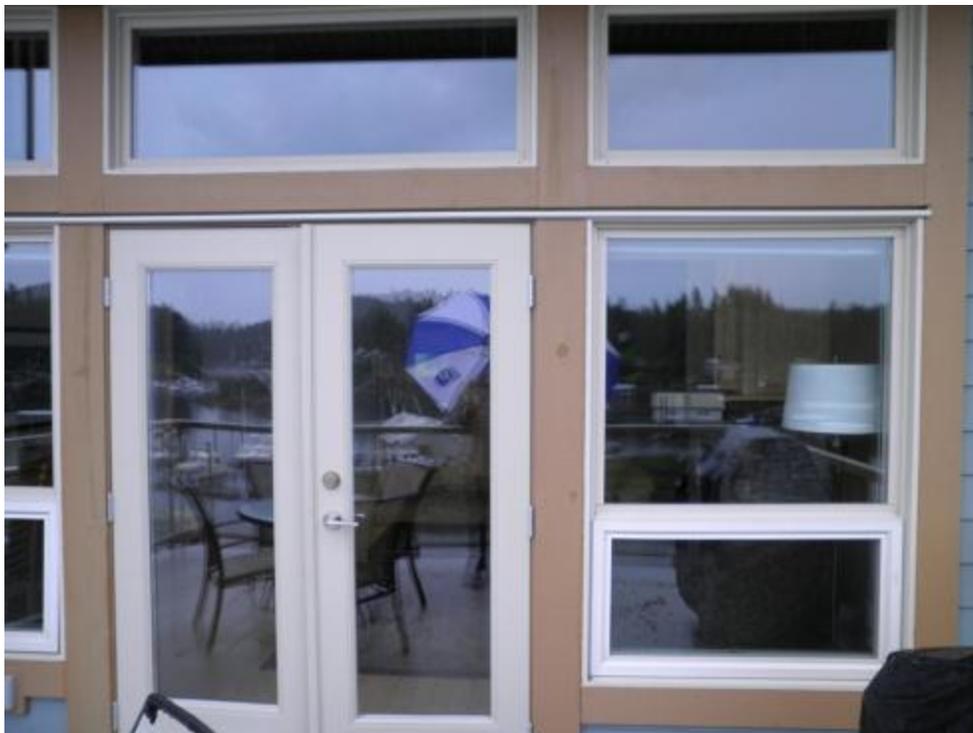
Reserve Component B203001	Wooden patio doors	
Properties	Wooden patio doors with tempered glass	
Potential Deterioration	Deterioration of patio doors mainly concerns aesthetic appeal.	
Condition Analysis	<i>Deterioration</i>	None observed
	<i>Repair/Replacement History</i>	None available
	<i>Overall Condition</i>	Good
	<i>Date of Installation</i>	2008
Life Cycle Analysis	<i>Chronological Age</i>	5 years
	<i>Estimated Useful Life</i>	30 years
	<i>Effective Age</i>	5 years
	<i>Remaining Useful Life</i>	25 years
	<i>Current Repair/Replacement Cost Estimate</i>	\$ 50,000
Replacement/Repair Estimates	<i>Estimated Year of Repair/Replacement</i>	2038
	Preventive Maintenance Regular cleaning.	
Recommendations	None

Wooden patio door

Wooden patio doors

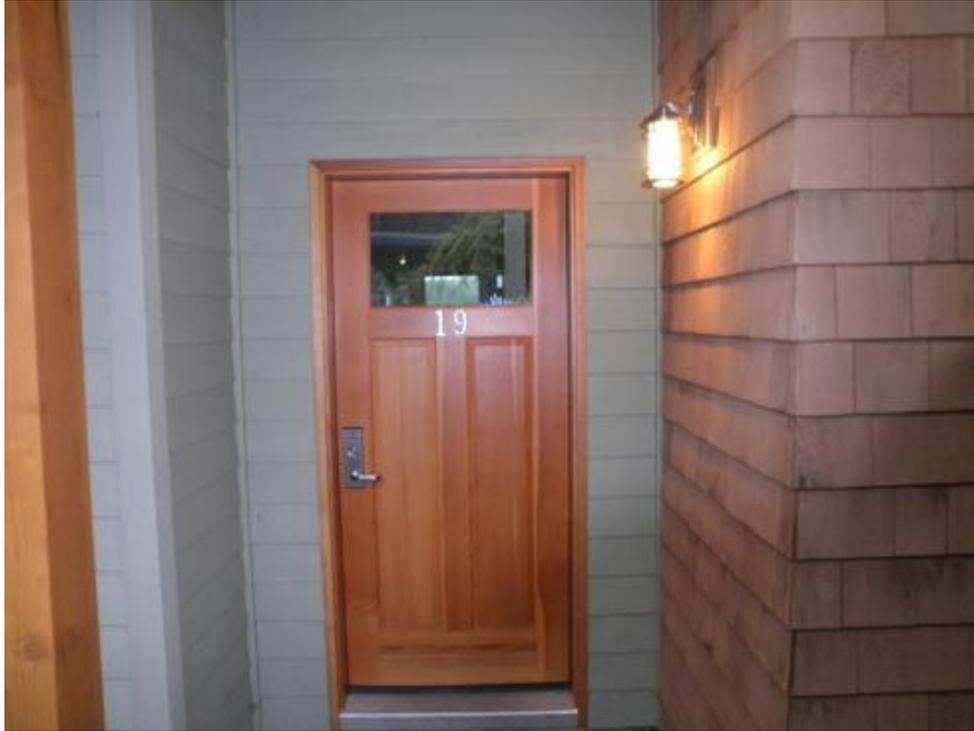
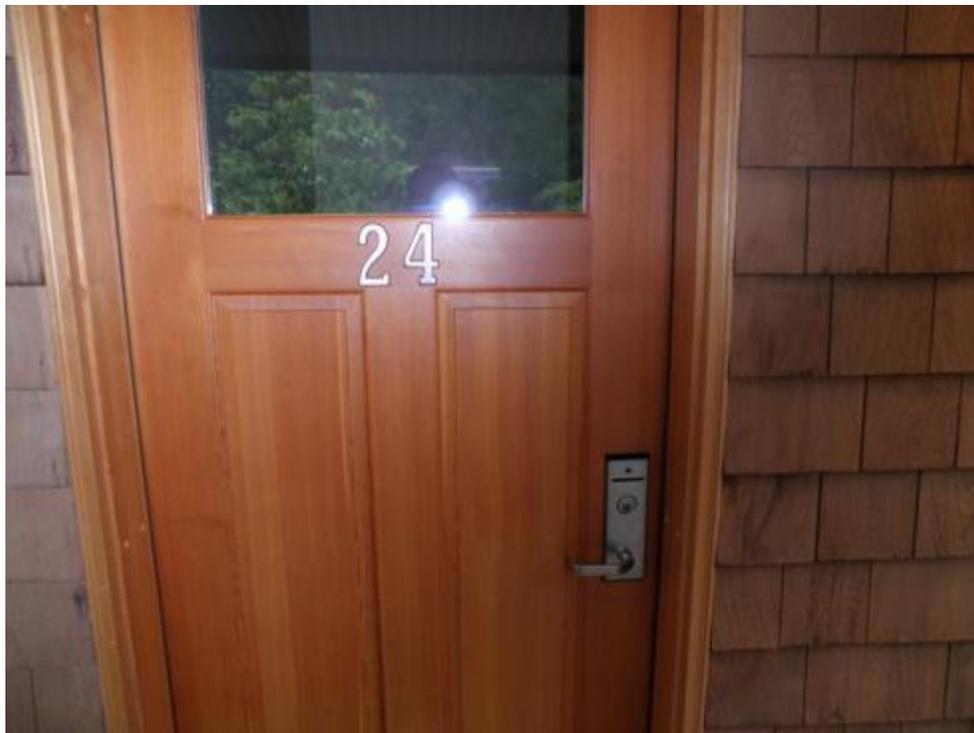
Reserve Component B203002	Unit entrance doors	
Properties	Wooden entrance doors	
Potential Deterioration	Deterioration of entrance doors mainly concerns aesthetic appeal.	
Condition Analysis	<i>Deterioration</i>	None observed
	<i>Repair/Replacement History</i>	None available
	<i>Overall Condition</i>	Good
Life Cycle Analysis	<i>Date of Installation</i>	2008
	<i>Chronological Age</i>	5 years
	<i>Estimated Useful Life</i>	30 years
	<i>Effective Age</i>	5 years
	<i>Remaining Useful Life</i>	25 years
Replacement/Repair Estimates	<i>Current Repair/Replacement Cost Estimate</i>	\$ 31,000
	<i>Estimated Year of Repair/Replacement</i>	2038
Preventive Maintenance	Regular cleaning.	
Recommendations	None

Wooden entrance door

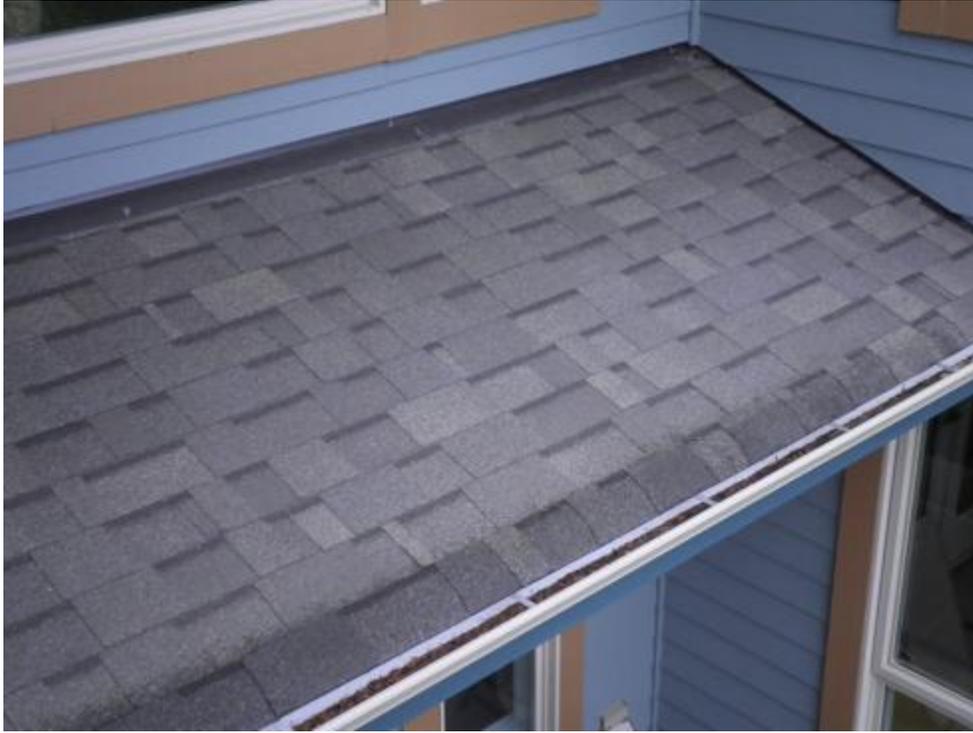
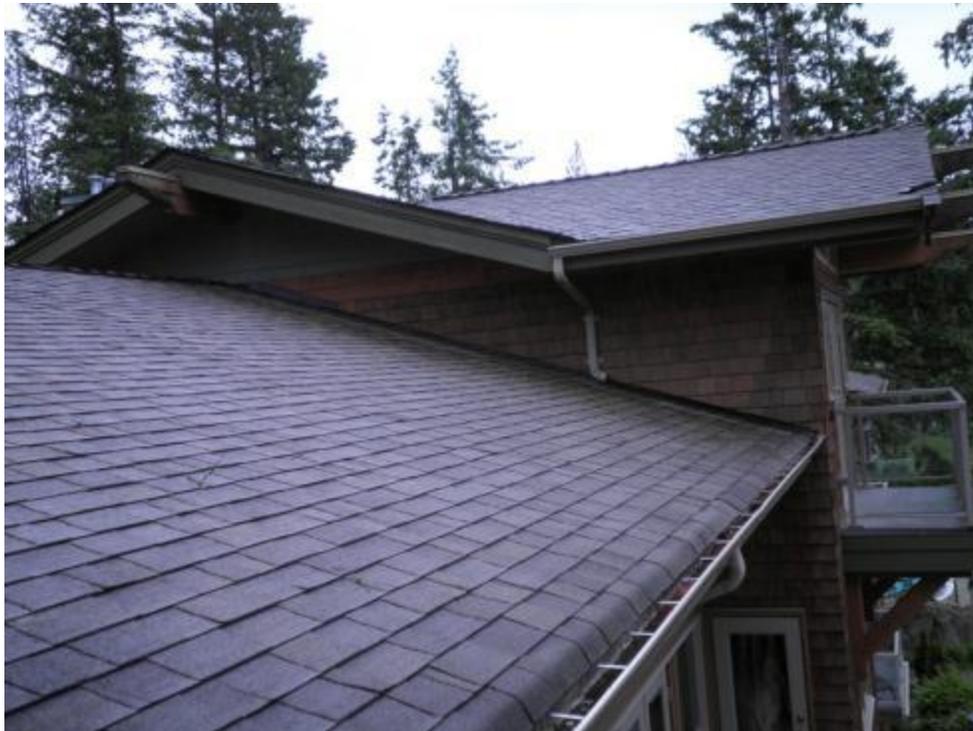
Reserve Component B301001	Roofing	
Properties	Fibreglass reinforced asphalt shingles	
Potential Deterioration	Asphalt shingles may lose surface flexibility over time. There may be shrinkage of the asphalt tiles, causing curling along the leading edges. Over time, the asphalt shingles may become brittle and start to break apart.	
Condition Analysis	<i>Deterioration</i>	None observed
	<i>Repair/Replacement History</i>	None available
	<i>Overall Condition</i>	Good
Life Cycle Analysis	<i>Date of Installation</i>	2008
	<i>Chronological Age</i>	5 years
	<i>Estimated Useful Life</i>	20 years
	<i>Effective Age</i>	5 years
	<i>Remaining Useful Life</i>	15 years
Replacement/Repair Estimates	<i>Current Repair/Replacement Cost Estimate</i>	\$ 140,301
	<i>Estimated Year of Repair/Replacement</i>	2028
Preventive Maintenance	inspect twice a year (spring and fall) and repair/replace any damage.	
Recommendations	None

Fibreglass reinforced asphalt shingles

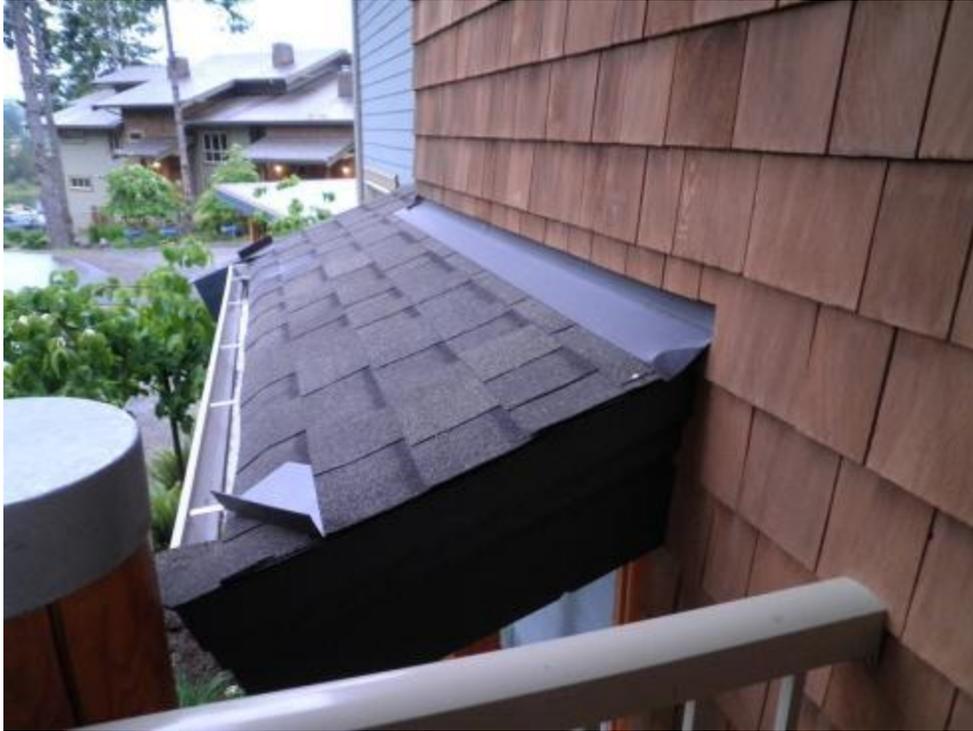
Reserve Component B301002	Roof flashing	
Properties	Metal flashing	
Potential Deterioration	Metal flashing may be affected by corrosion due to exposure to the elements. Furthermore, strong winds may dislodge flashings which are improperly secured.	
Condition Analysis	<i>Deterioration</i>	None observed
	<i>Repair/Replacement History</i>	None available
	<i>Overall Condition</i>	Good
	<i>Date of Installation</i>	2008
Life Cycle Analysis	<i>Chronological Age</i>	5 years
	<i>Estimated Useful Life</i>	30 years
	<i>Effective Age</i>	5 years
	<i>Remaining Useful Life</i>	25 years
	Replacement/Repair Estimates	<i>Current Repair/Replacement Cost Estimate</i>
<i>Estimated Year of Repair/Replacement</i>		2038
Preventive Maintenance	inspect twice a year (spring and fall) and repair/replace any damage.	
Recommendations	None

Metal flashing

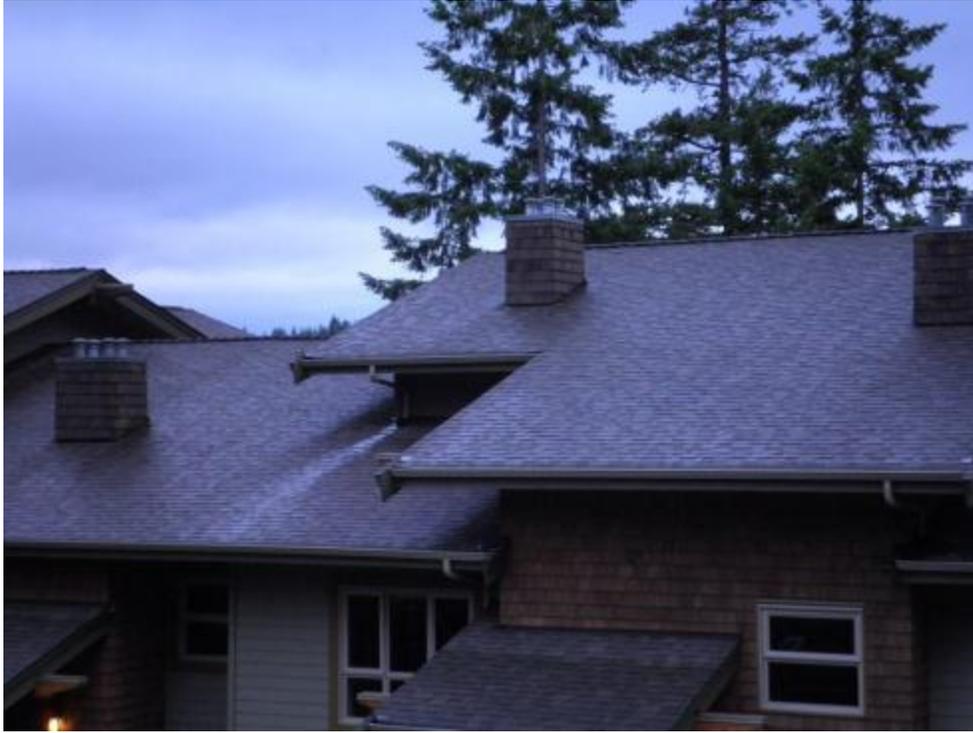
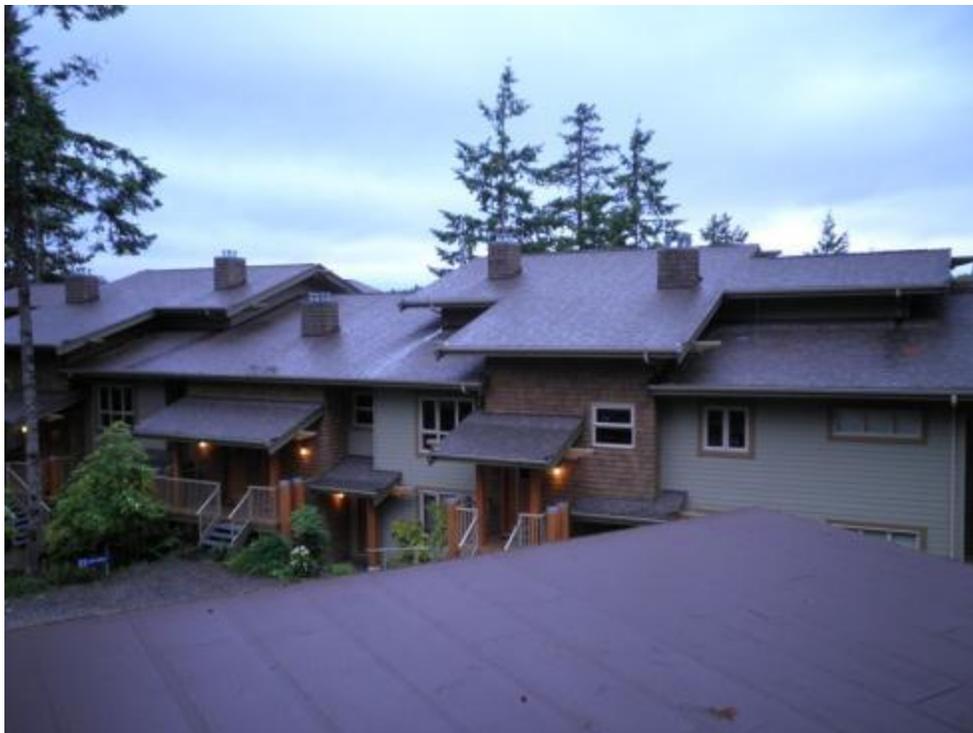
Reserve Component B302003	Chimneys	
Properties	Cedar shingle clad vent chimneys	
Potential Deterioration	Chimney chase caps may be dislodged during high winds. Corrosion to chimney cap may allow water ingress into chimney chase. Deterioration of sealant around collar flashing may cause water leakage into the building from the chimney.	
Condition Analysis	<i>Deterioration</i>	None observed
	<i>Repair/Replacement</i>	None available
	<i>History</i>	
	<i>Overall Condition</i>	Good
Life Cycle Analysis	<i>Date of Installation</i>	2008
	<i>Chronological Age</i>	5 years
	<i>Estimated Useful Life</i>	30 years
	<i>Effective Age</i>	5 years
	<i>Remaining Useful Life</i>	25 years
Replacement/Repair Estimates	<i>Current Repair/Replacement Cost Estimate</i>	\$ 51,680
	<i>Estimated Year of Repair/Replacement</i>	2038
Preventive Maintenance Recommendations	Inspect annually and repair as needed.	
Recommendations	None

Cedar shingle clad vent chimneys

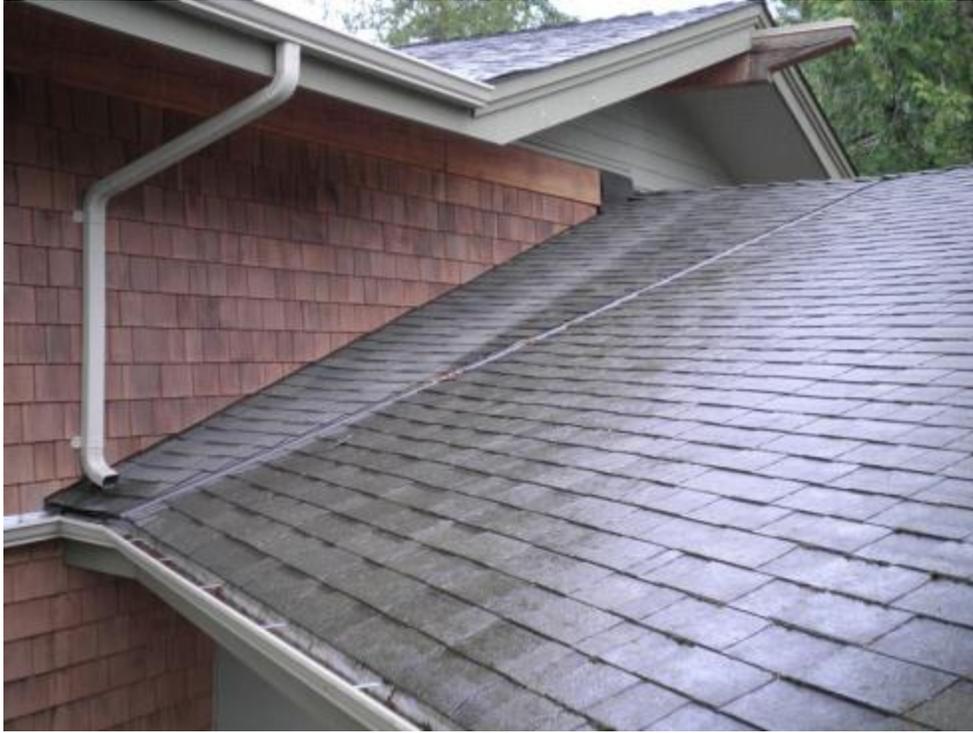
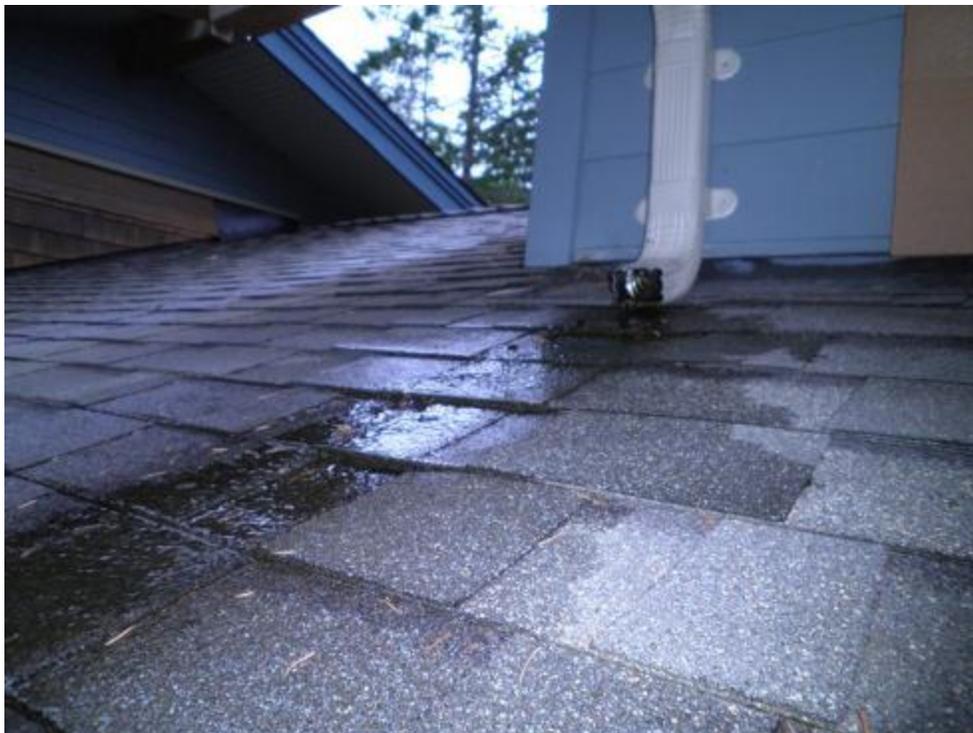
Reserve Component B302004	Gutters and downspouts	
Properties	5" continuous pre-finished aluminum gutter	
Potential Deterioration	Gutters and downspouts may be clogged by organic debris over time, leading to poor drainage.	
Condition Analysis	<i>Deterioration</i>	None observed
	<i>Repair/Replacement History</i>	None available
	<i>Overall Condition</i>	Good
Life Cycle Analysis	<i>Date of Installation</i>	2008
	<i>Chronological Age</i>	5 years
	<i>Estimated Useful Life</i>	30 years
	<i>Effective Age</i>	5 years
	<i>Remaining Useful Life</i>	25 years
Replacement/Repair Estimates	<i>Current Repair/Replacement Cost Estimate</i>	\$ 25,092
	<i>Estimated Year of Repair/Replacement</i>	2038
Preventive Maintenance	Clean and remove debris annually.	
Recommendations	None

Gutters and downspouts

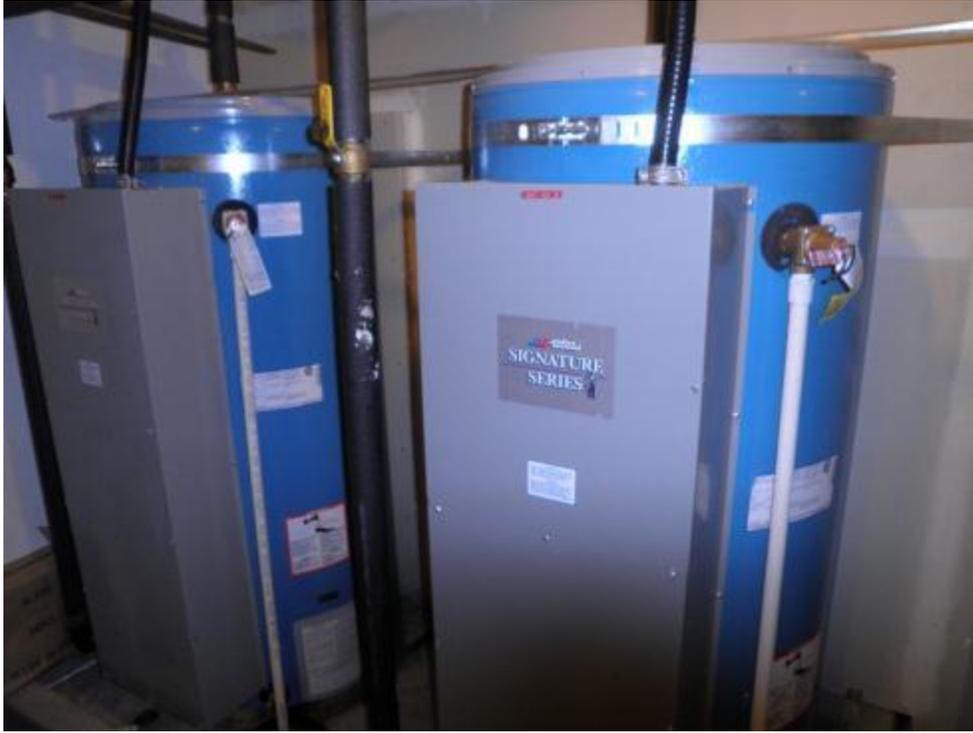
Reserve Component D202002	Water storage	
Properties	Hot water tank (John Wood signature series)	
Potential Deterioration	Storage tanks tend to require replacement with deterioration of the liner and/or corrosion of the tank body, leading to obstructions and leakage	
Condition Analysis	<i>Deterioration</i>	None observed
	<i>Repair/Replacement History</i>	Two water storage tanks were replaced in Buildings B and C in 2012 and 2013.
	<i>Overall Condition</i>	Good
Life Cycle Analysis	<i>Date of Installation</i>	2008
	<i>Chronological Age</i>	5 years
	<i>Estimated Useful Life</i>	10 years
	<i>Effective Age</i>	5 years
	<i>Remaining Useful Life</i>	5 years
Replacement/Repair Estimates	<i>Current Repair/Replacement Cost Estimate</i>	\$ 12,000
	<i>Estimated Year of Repair/Replacement</i>	2018
Preventive Maintenance	Annual inspection.	
Recommendations	None

Hot water tanks

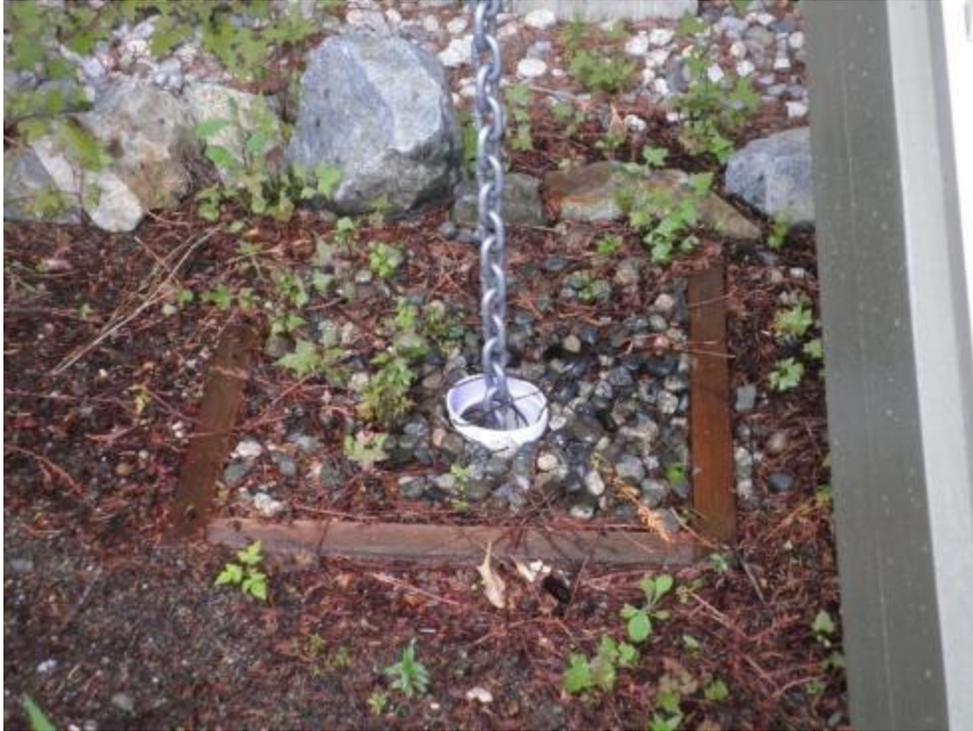
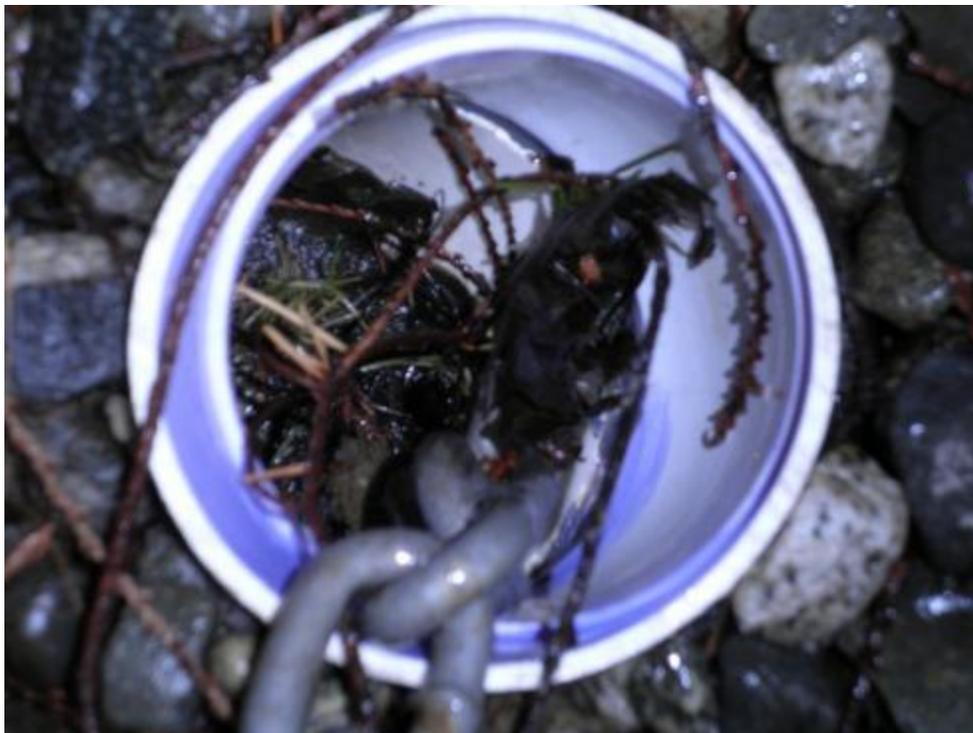
Rain water drainage

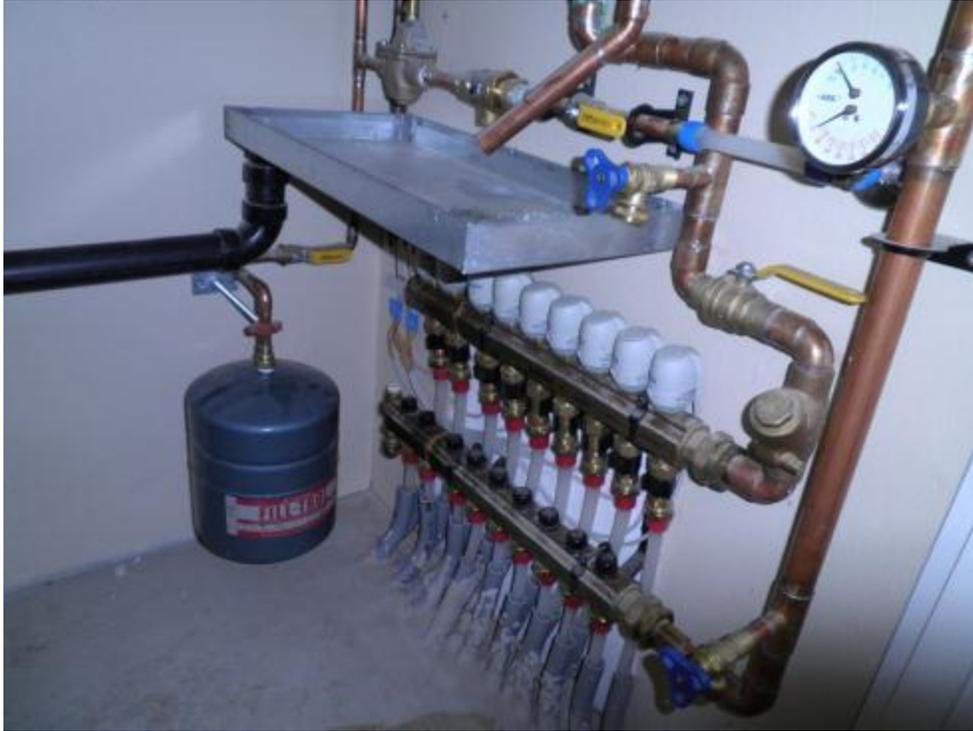
In-floor radiant heating system

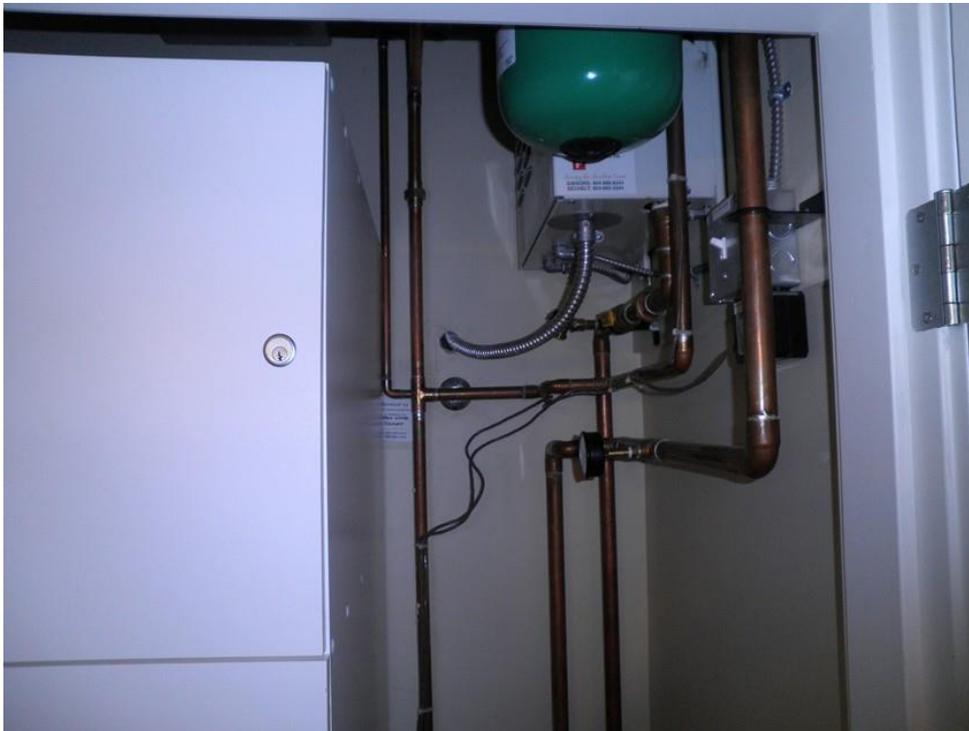
Boiler(white) setup with expansion tank(green)

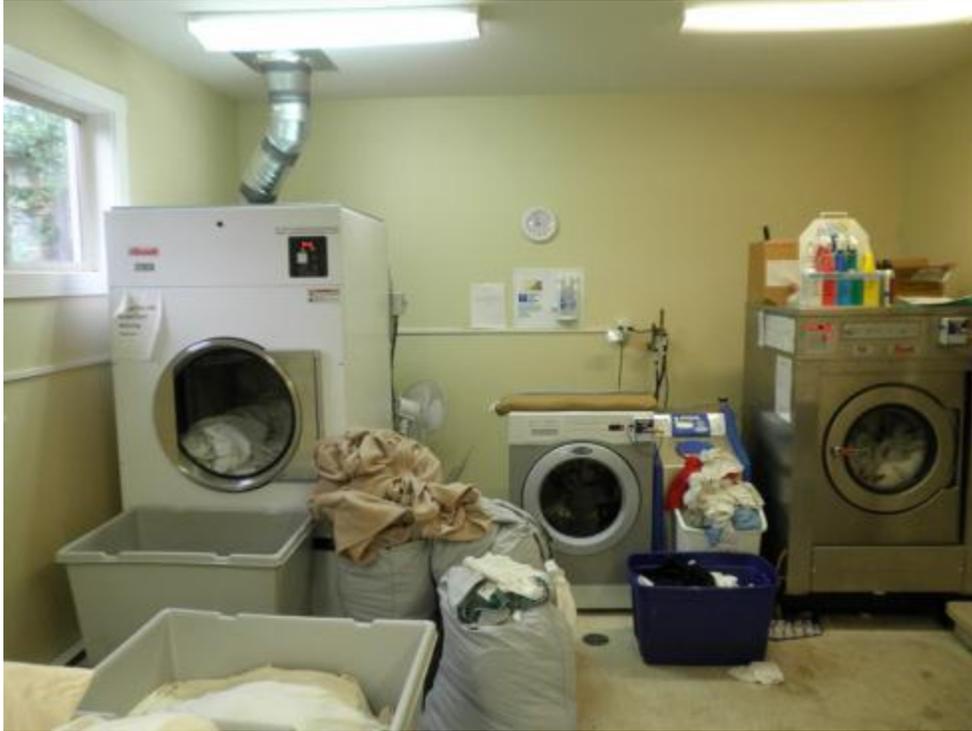
Maintenance facility equipment – washers and dryers

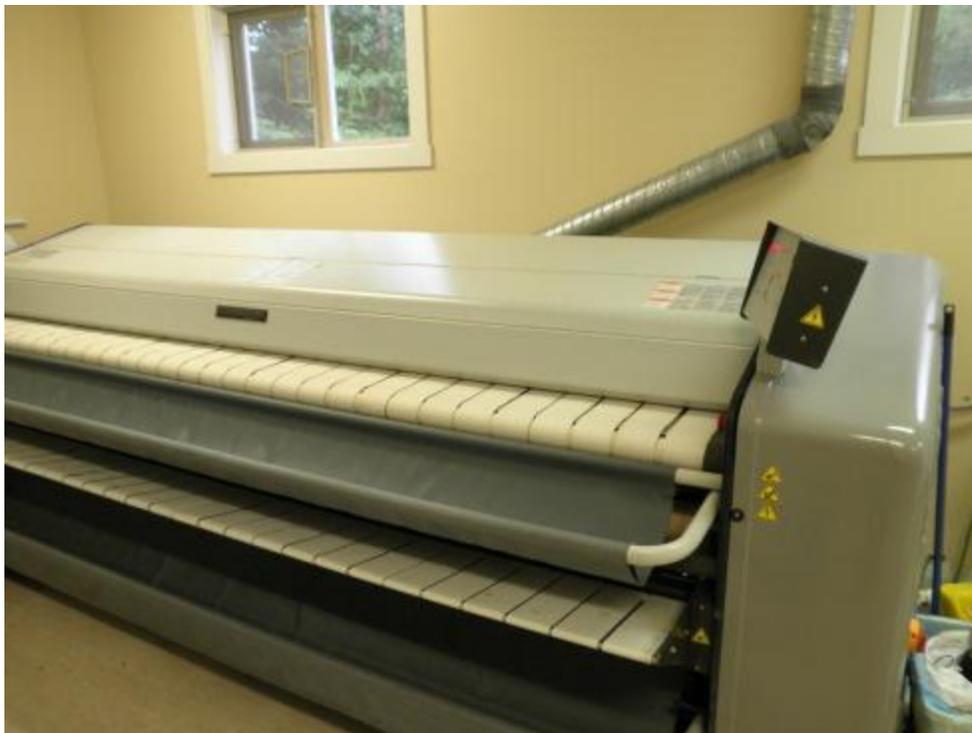
Maintenance facility equipment – ironing system

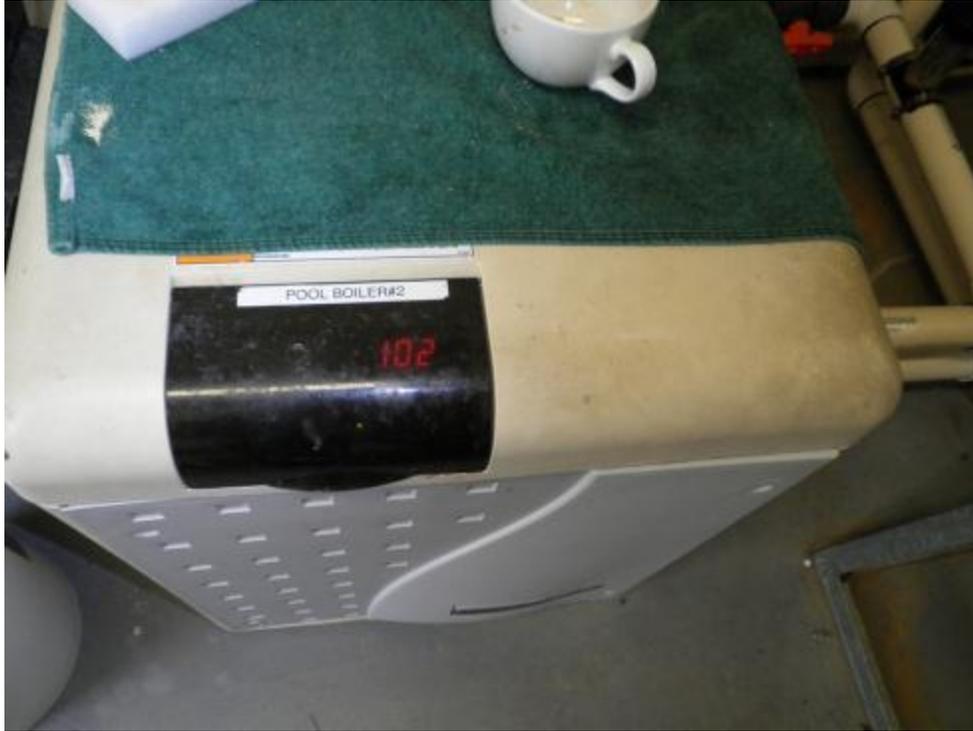
Pool building mechanical equipment - boiler

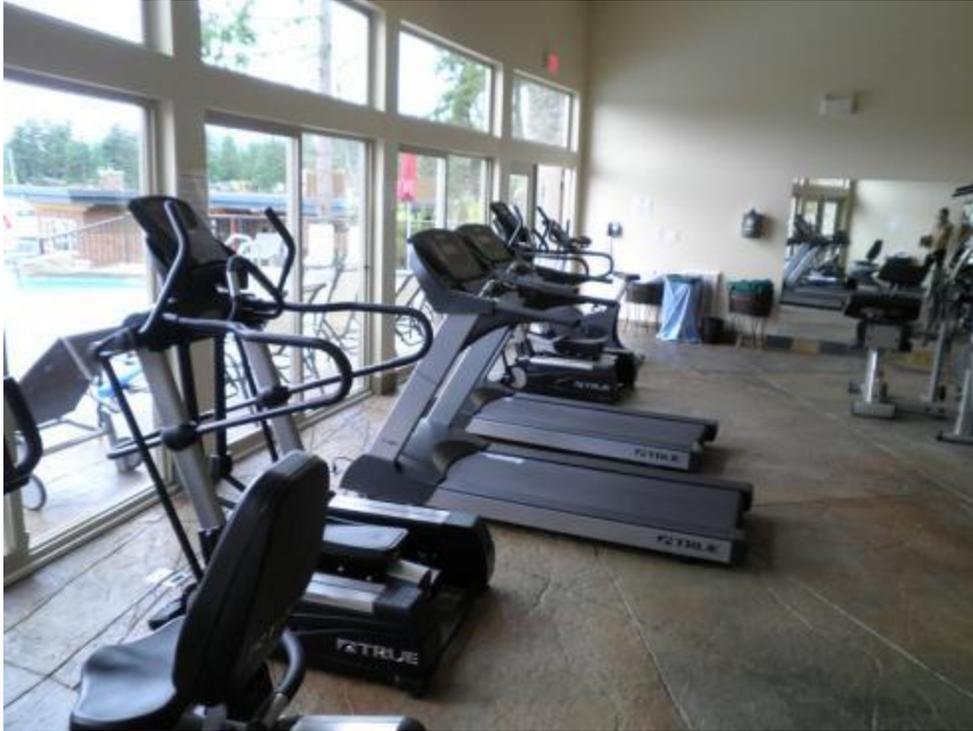
Fitness equipment

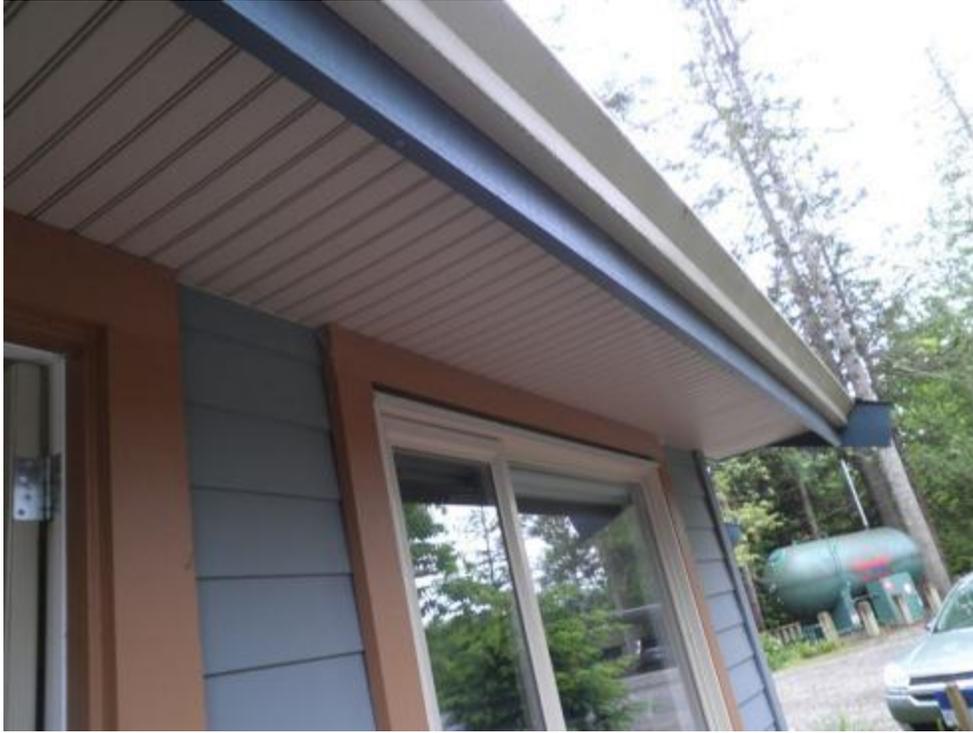
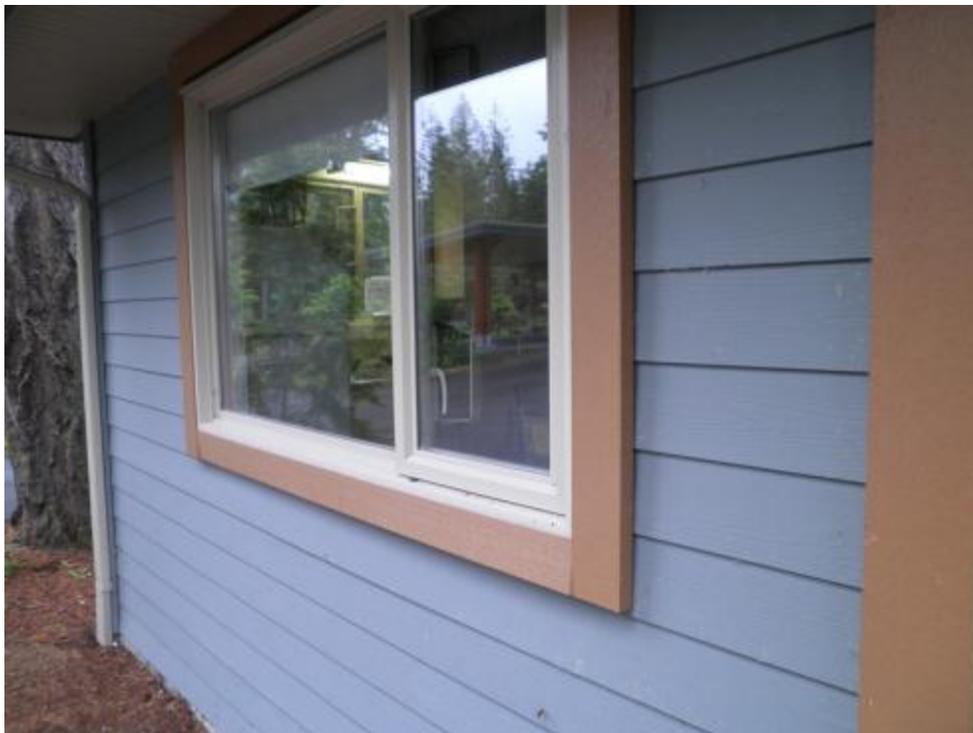
Maintenance facility building exterior
