Depreciation Report

BCS 2634 – Painted Boat Resort Spa and Marina

**RE: Depreciation Report for Strata Plan BCS 2634
File No. 20130318-DR-BCS2634**

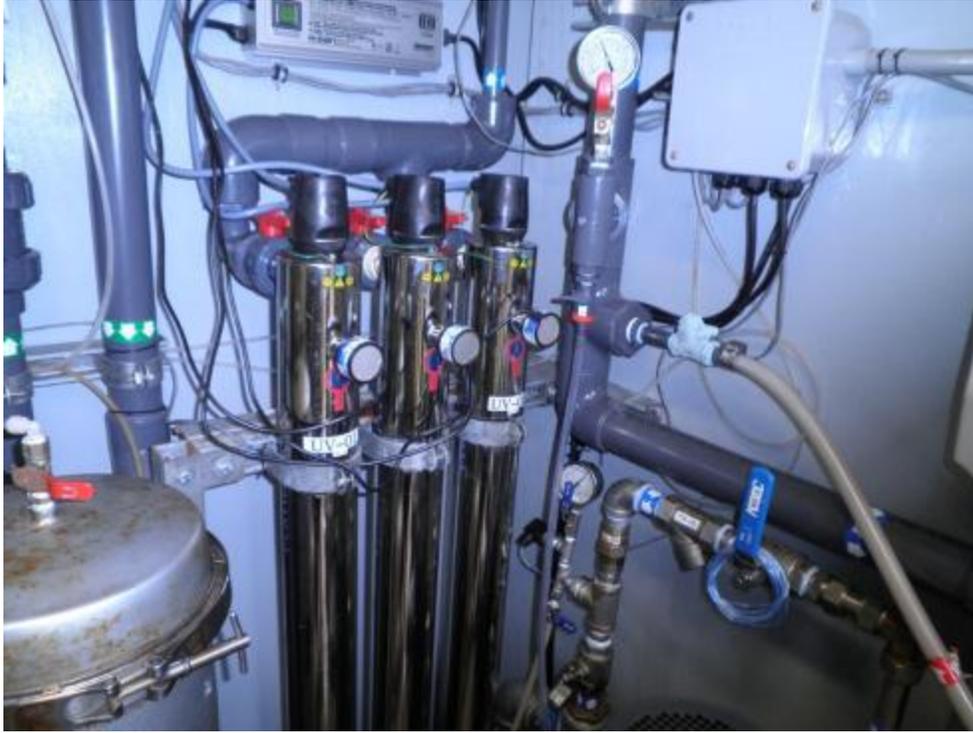
UV filtration apparatus

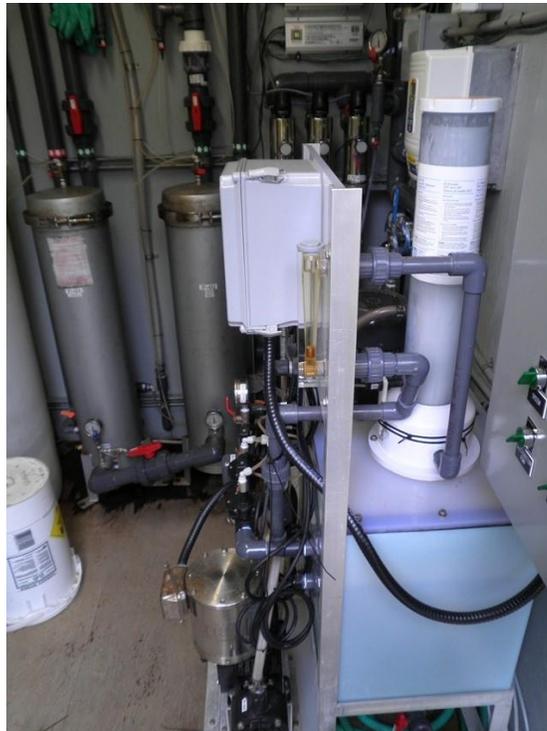
Water treatment facility

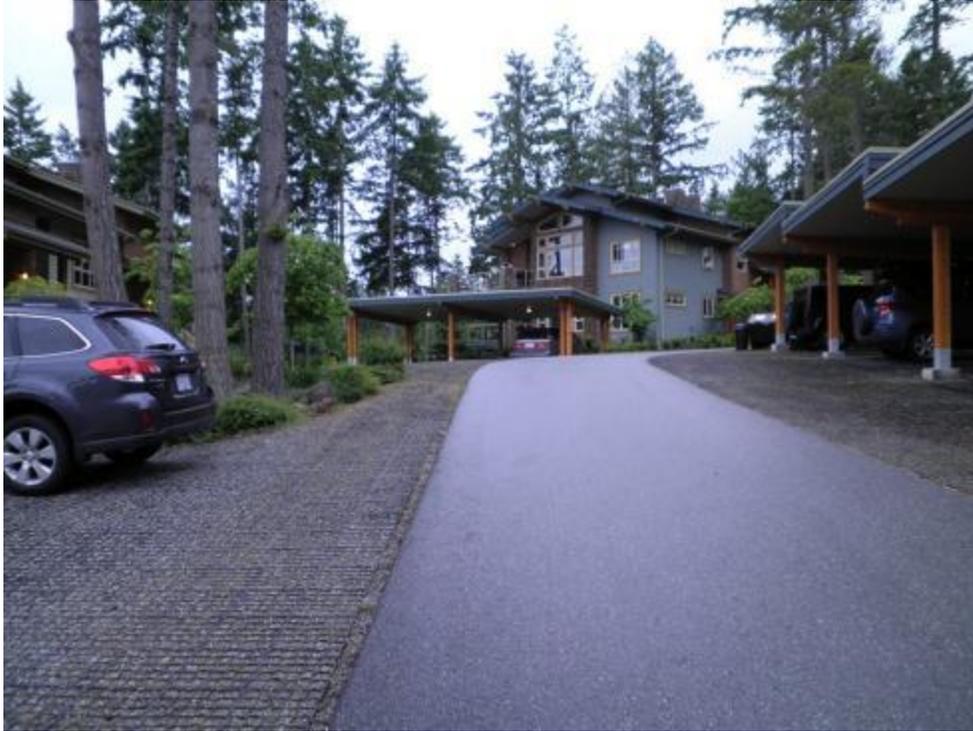
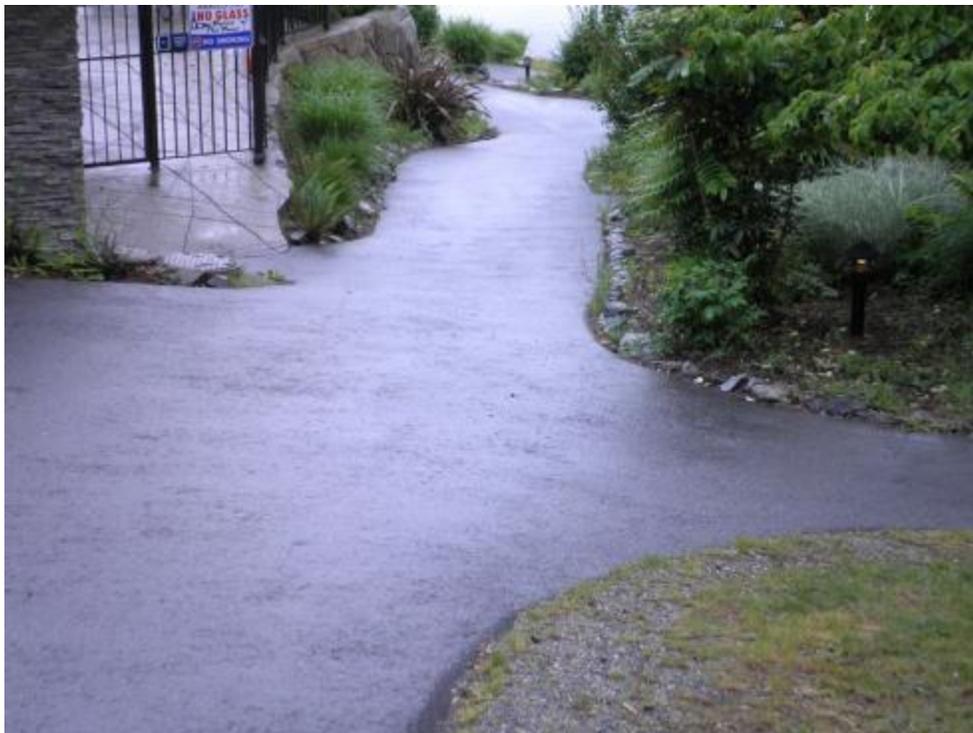
Asphalt paving

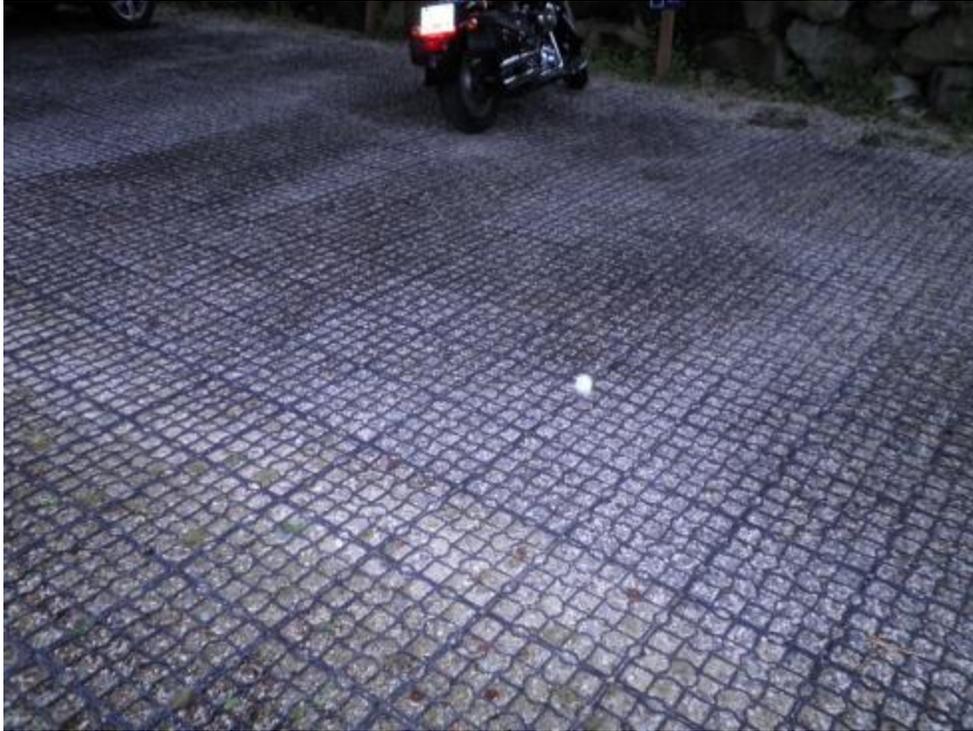
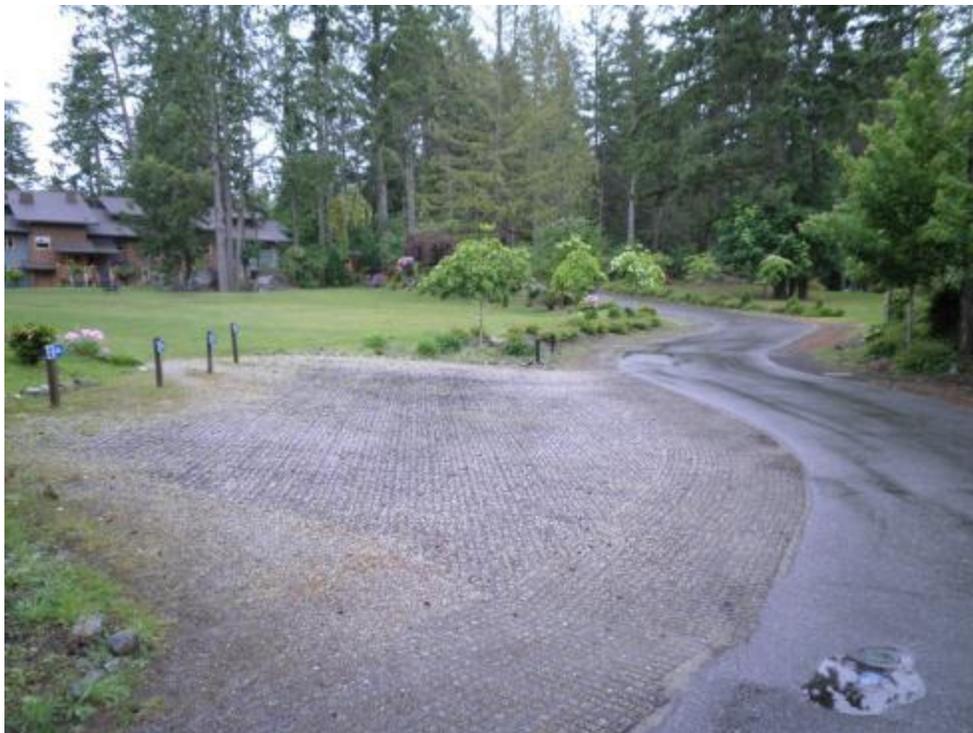
Eco-grid paving and parking area

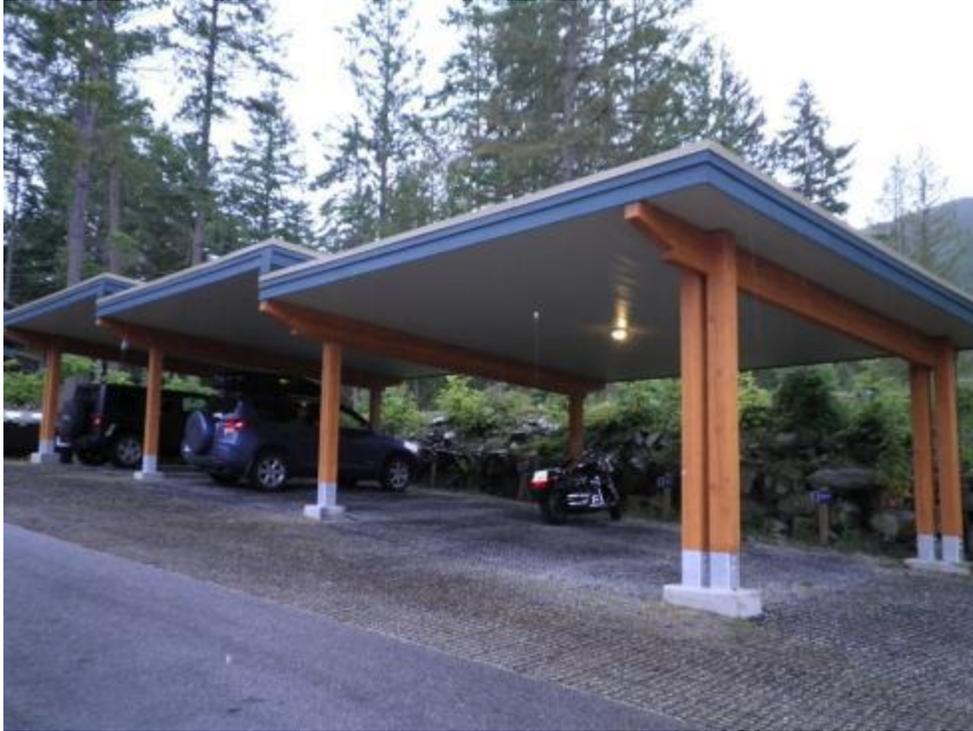
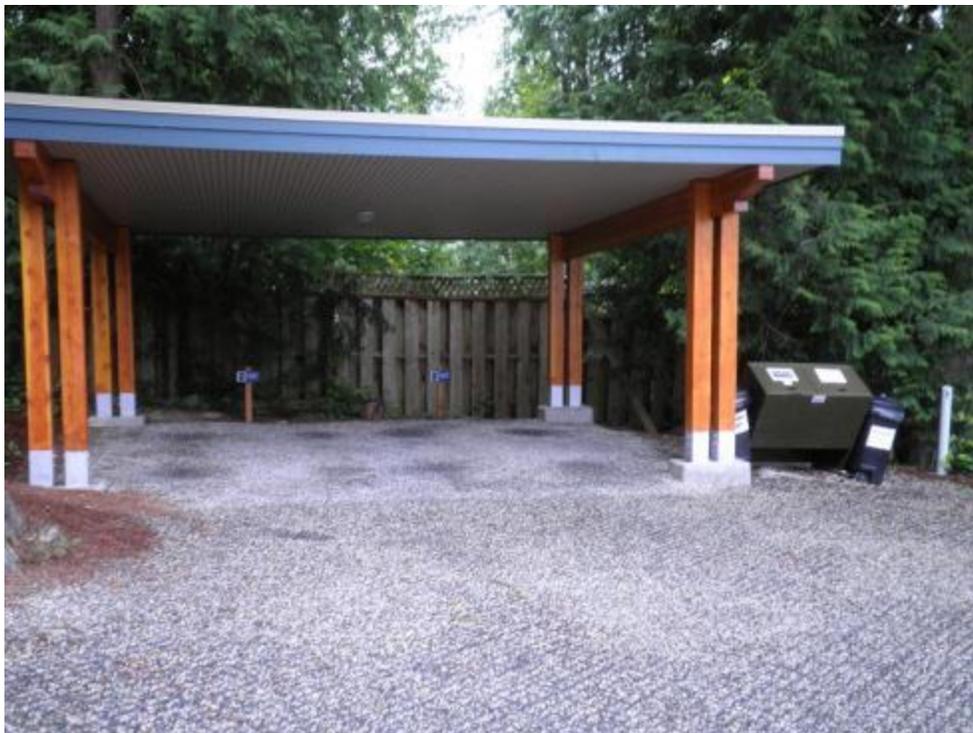
Carport structure

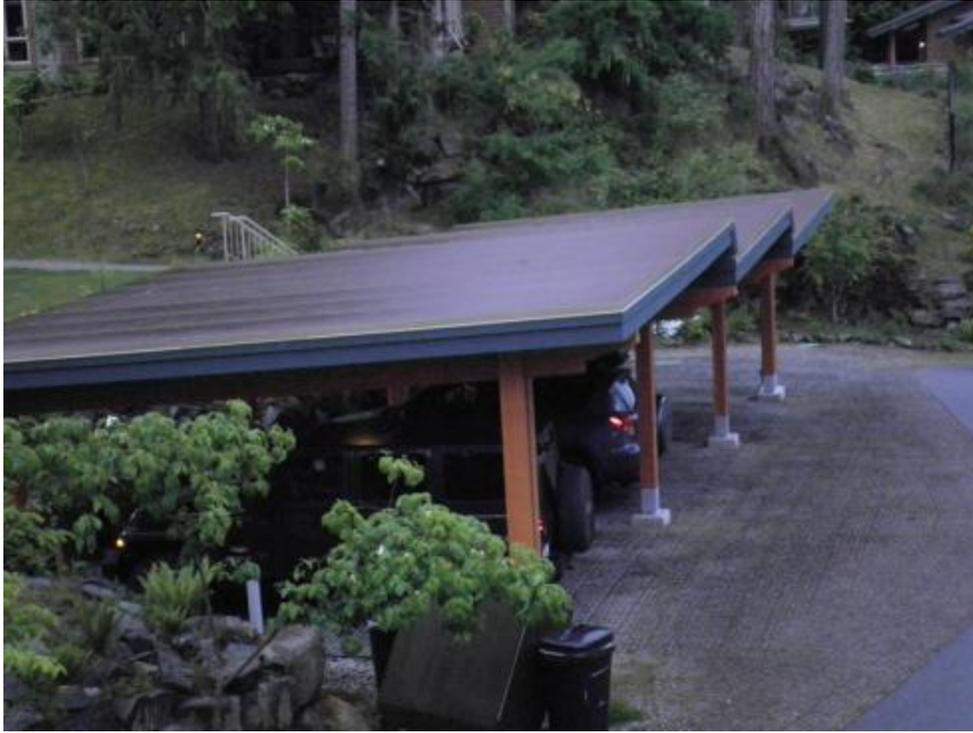
Carport roof

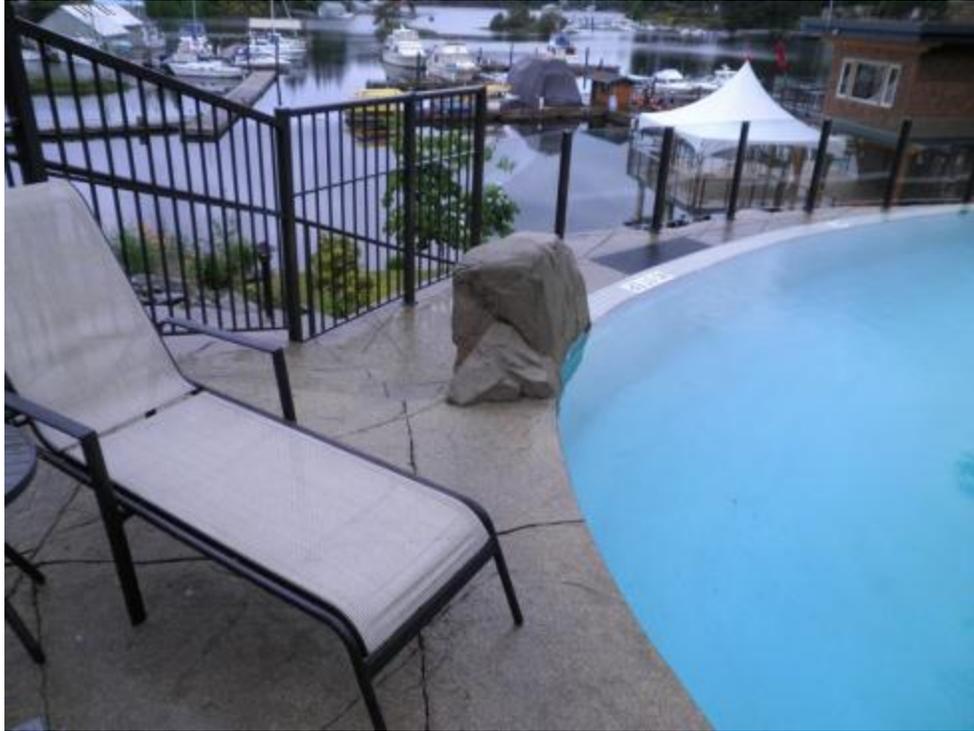
Infinity pool and surrounding deck

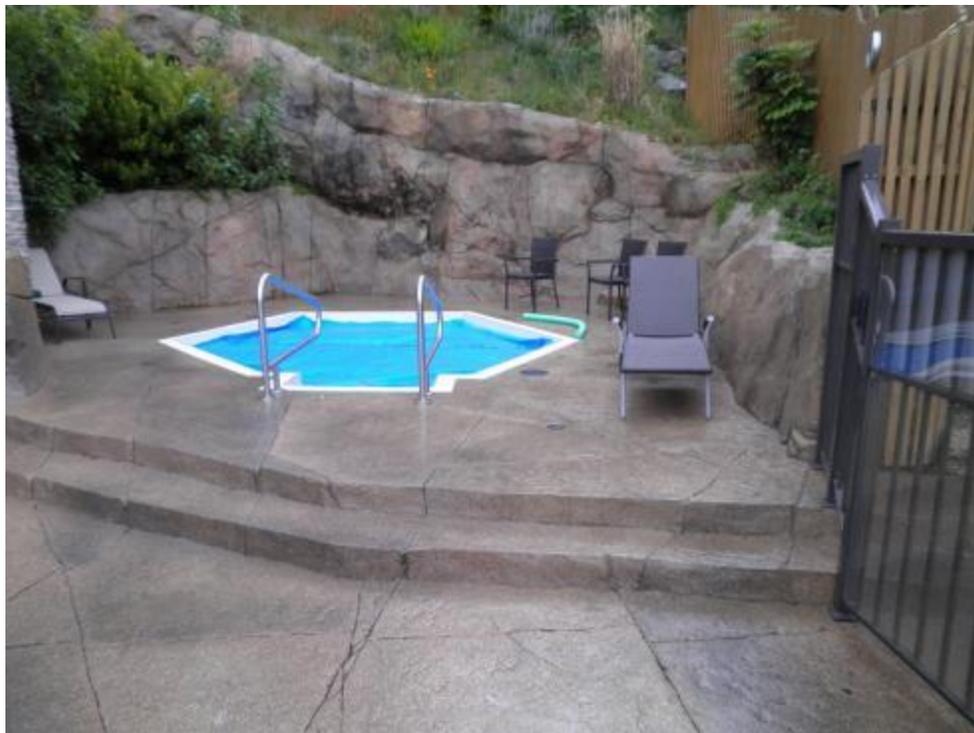
Hot tub

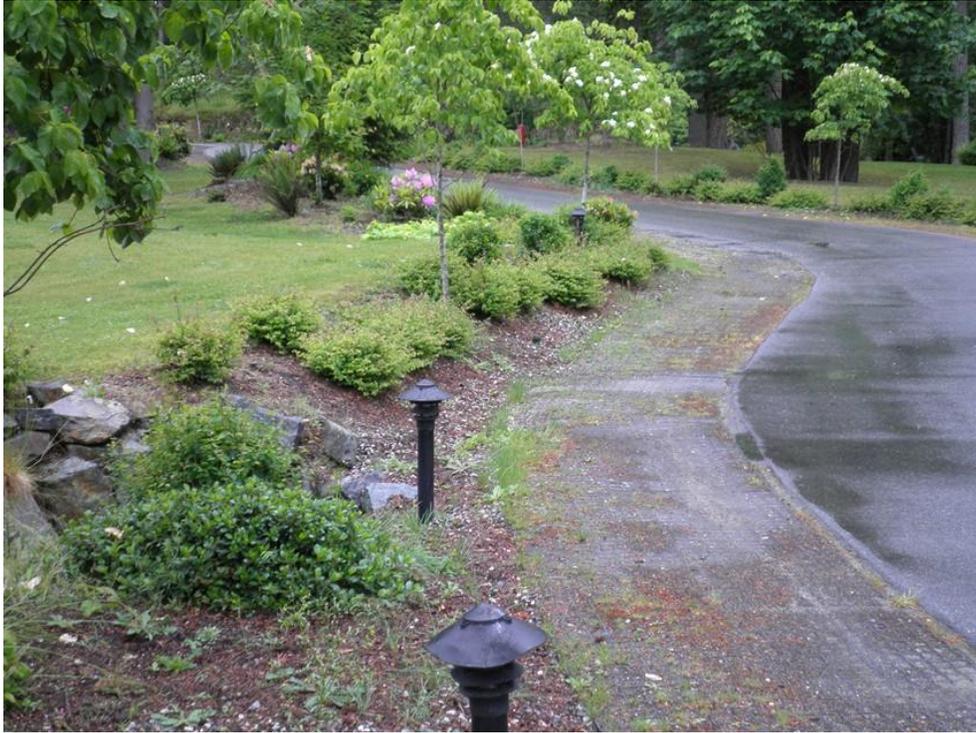
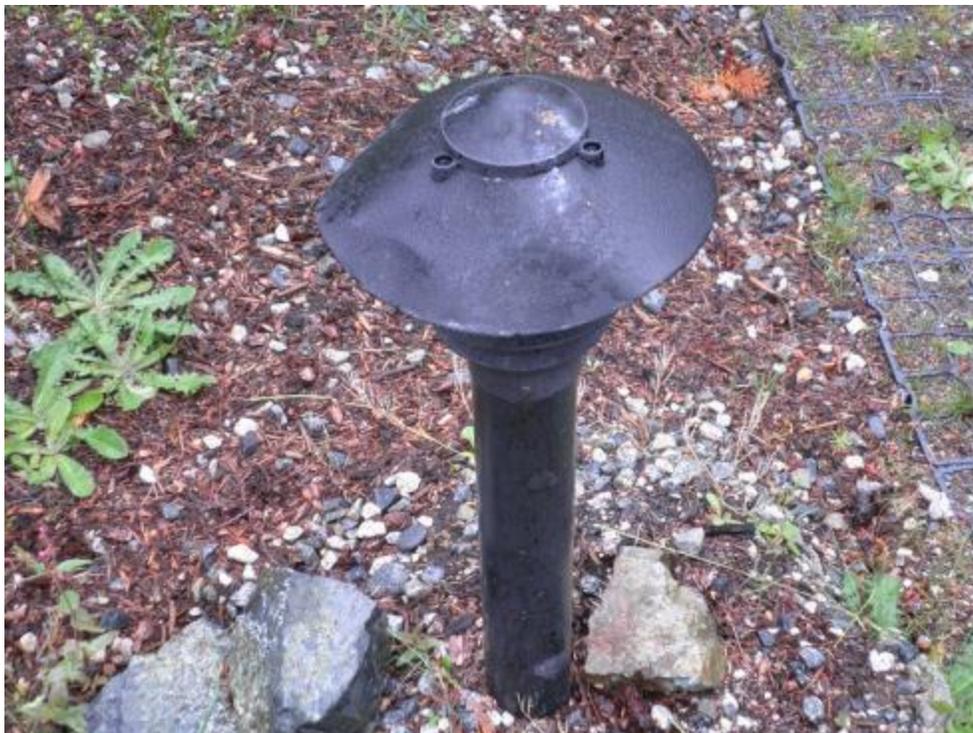
Reserve Component G402001	Site lighting	
Properties	Low incandescent lighting along roads and paving	
Potential Deterioration	Lighting may be subject to electrical failures.	
Condition Analysis	<i>Deterioration</i>	None observed
	<i>Repair/Replacement History</i>	None available
	<i>Overall Condition</i>	Good
	<i>Date of Installation</i>	2008
Life Cycle Analysis	<i>Chronological Age</i>	5 years
	<i>Estimated Useful Life</i>	25 years
	<i>Effective Age</i>	5 years
	<i>Remaining Useful Life</i>	20 years
	<i>Current Repair/Replacement Cost Estimate</i>	\$ 25,000
Replacement/Repair Estimates	<i>Estimated Year of Repair/Replacement</i>	2033
	Preventive Maintenance Annual inspection.	
Recommendations	None

Low incandescent lighting

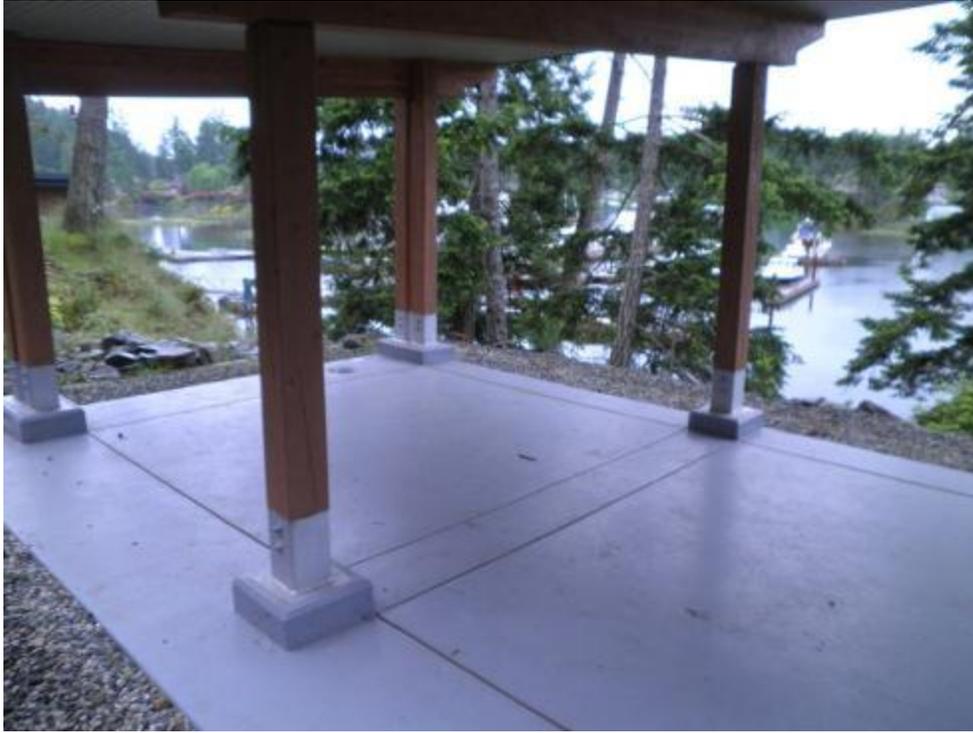
Reserve Component G204009	Zen pavilion paved area	
Properties	Concrete paving under zen pavillion with wooden posts.	
Potential Deterioration	Concrete paving may develop cracks over time due to mechanics of concrete expansion and soil movements.	
Condition Analysis	<i>Deterioration</i>	None observed
	<i>Repair/Replacement History</i>	None available
	<i>Overall Condition</i>	Good
Life Cycle Analysis	<i>Date of Installation</i>	2008
	<i>Chronological Age</i>	5 years
	<i>Estimated Useful Life</i>	50 years
	<i>Effective Age</i>	5 years
	<i>Remaining Useful Life</i>	45 years
Replacement/Repair Estimates	<i>Current Repair/Replacement Cost Estimate</i>	\$ 1800
	<i>Estimated Year of Repair/Replacement</i>	2058
Preventive Maintenance	Cement admixture for permanent repairs of minor cracks.	
Recommendations	None

Concrete paving under zen pavilion

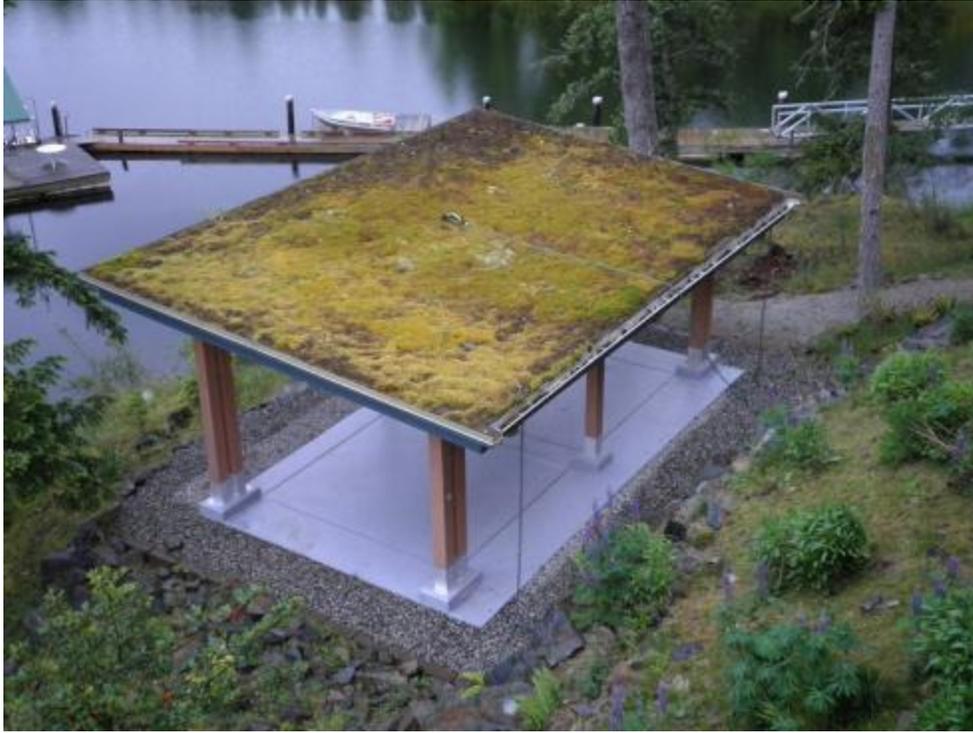
Reserve Component G20400901	Zen pavilion roof	
Properties	SBS roofing with vinyl soffits under roof	
Potential Deterioration	Cracking may appear in the SBS membrane due to differential rates of expansion. Insufficient overlap of the seams may also lead to water ingress into structure.	
Condition Analysis	<i>Deterioration</i>	None observed
	<i>Repair/Replacement History</i>	None available
	<i>Overall Condition</i>	Good
	<i>Date of Installation</i>	2008
Life Cycle Analysis	<i>Chronological Age</i>	5 years
	<i>Estimated Useful Life</i>	15 years
	<i>Effective Age</i>	5 years
	<i>Remaining Useful Life</i>	10 years
	Replacement/Repair Estimates	<i>Current Repair/Replacement Cost Estimate</i>
	<i>Estimated Year of Repair/Replacement</i>	2023
Preventive Maintenance	Inspect twice a year (spring and fall) and repair/replace any damage.	
Recommendations	None

Zen pavilion roof
